Wellhead Corrosion Prevention Services

Case Study

Life Asset Extension for Corroded Wellhead

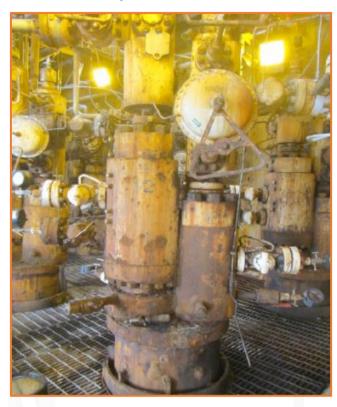
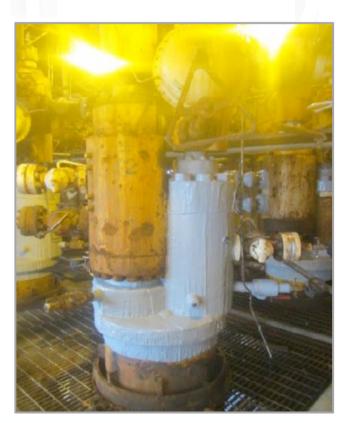
Wellhead Body

There was severe corrosion on almost all the substrates that were inspected on the platform during the initial inspection on the 23rd December.

The Oxifree TM198 coating was applied throughout all corroded parts of wellhead to protect them from further corrosion and contaminants. The coating provides protection immediately and will provide 100% protection against further corrosion and contamination. The coating may be removed for inspection at any time.

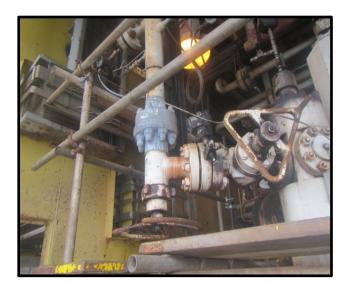
The inspection outcome showed TM198 had provided 100% corrosion protection to the wellhead.

There was some contamination/grease/dust which had settled on the outer surface of the coating. This is part of the passive barrier that Oxifree is providing to the substrate.

The coating is intact and there was no damage to the coating which is able to withstand impact from any scaffolding activities.

A uniform and minimum thickness of 4mm remained using measurement from Elcometer.

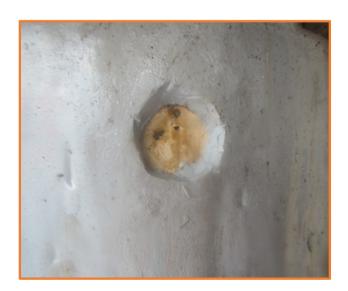
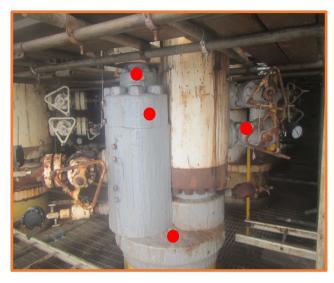
Small circular cuts to the coating were made in line with inspection guidlelines (red dots in the picture on the right) and zero corrosion was observed. There were inhibitor oils on the surface of the substrate where the coating removed, which was exuded by the material upon application. These oils actively protect the surface of the substrate.

These holes can be simply refilled as new material will adhere to the existing coating.
