Protection of a drain valve showcases TM198 success

Case Study

Location	CPG Morelos, Coatzacoalcos
Local Environment	Onshore
Date	November 2014
Condition	Dry, windy
Total Coatings	1
Substrate Type	Valve
Duration	1 day

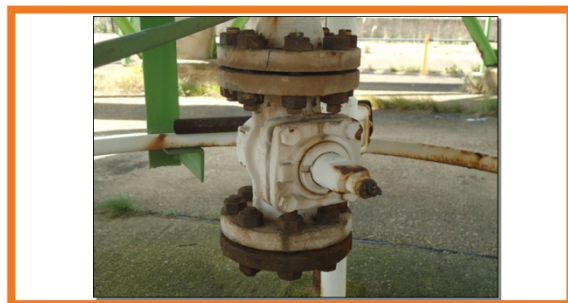
The drain valve was cleaned of contaminants and grease.

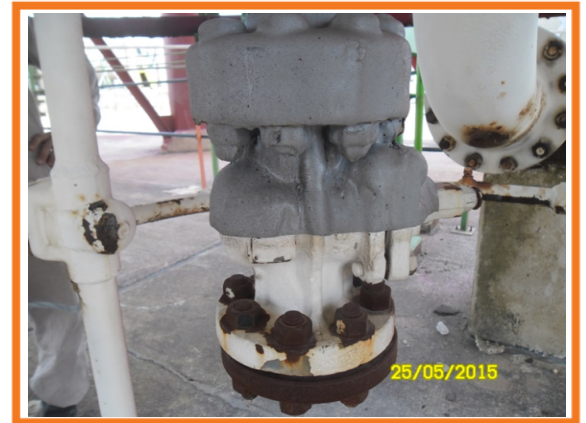
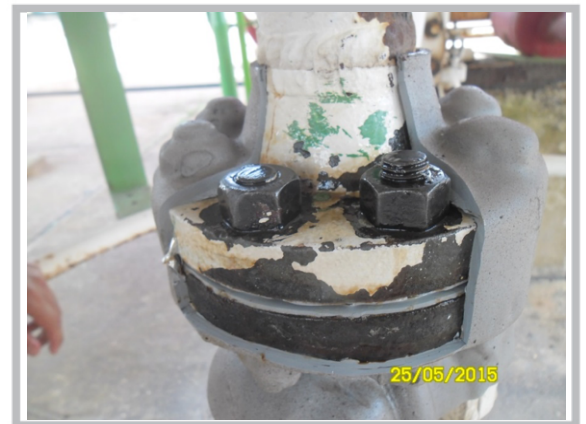
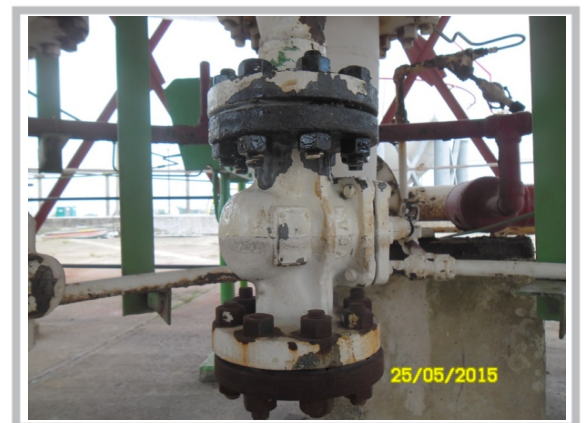
On the protected substrate the existing coating was cut away (without damage) to reveal that no further corrosion had occurred. This ease for inspection is a fundamental feature of TM198. Once a small section has been cut away, the open area can be refilled.

On full inspection there was no evidence of any corrosion on the protected surface and the valve parts were fully operational.
