Protecting infrastructure at a gas manufacturing facility

Case Study

## Protecting a vent/exhaust connection to prevent leakages

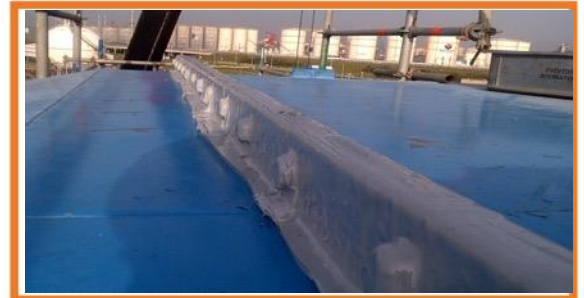
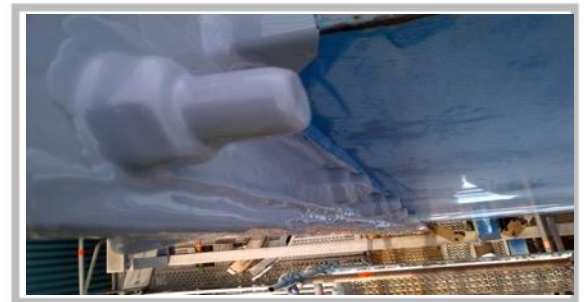
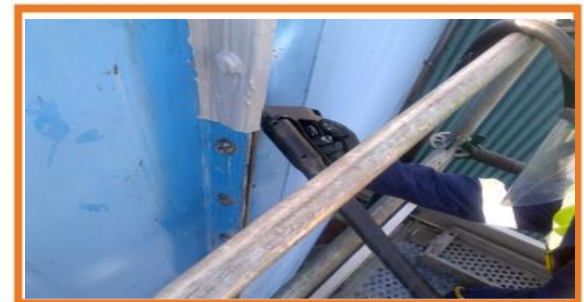
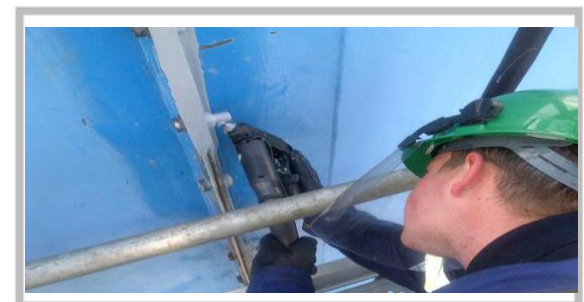
Application photos

The venting of gas and heat by-products was causing on-going maintenance issues due to the size and weight of the vent (approx. 12m x 12m) with the bolted flange connection suffering from seal issues from corrosion. A solution was required to protect the flange from corrosion, thus stopping unwanted contamination from the outside getting into the duct.

The project involved encapsulation of the entire joint along the rectangular edge, which measured approximately 48 metres along a straight edge at a depth of 6mm and profile of 10cm. The project was successfully completed within the 2 days.

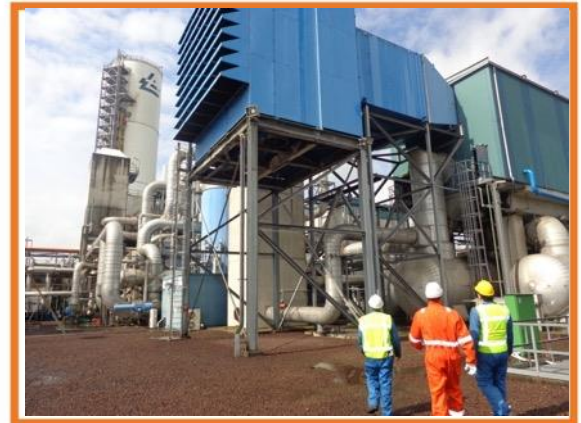
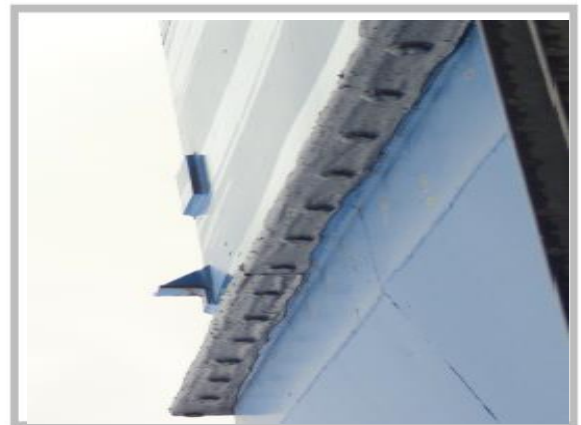
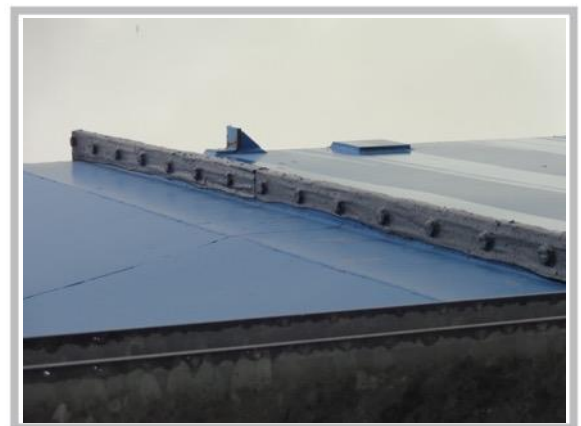
*Inspection photos*

Access was limited as there was no scaffolding in place, so a QA/QC inspector from our representative climbed the adjacent ladders both sides of the flange to inspect visually and take photos. The Client was only concerned about an area of coating underneath the flange where he thought there was a crack. With the limited accessibility available no cracks or imperfections were visible in the coating and apart from external contaminants such as dust it looked in a very similar state to the initial application 19 months ago.

Upon our next visit, a camera with a strong telephoto lens will be used to specifically examine this area to gather more accurate information.

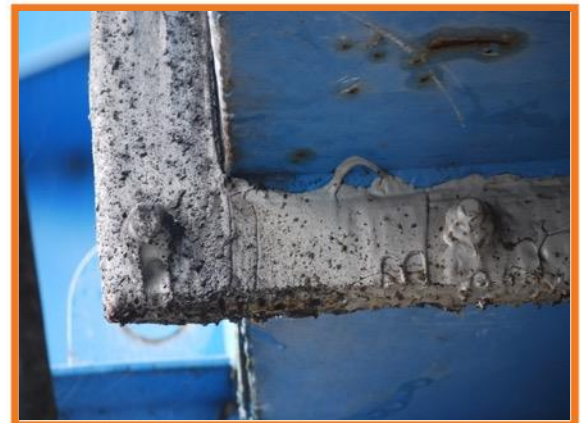
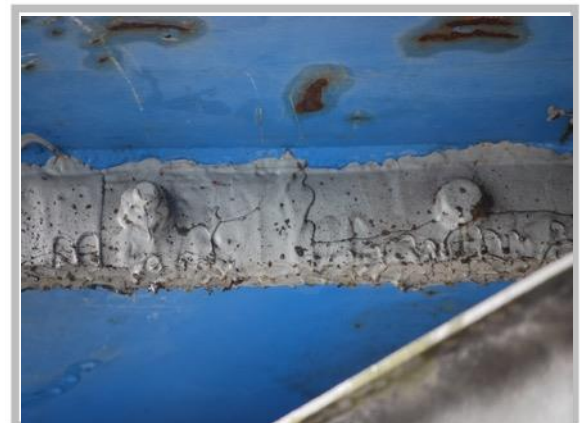
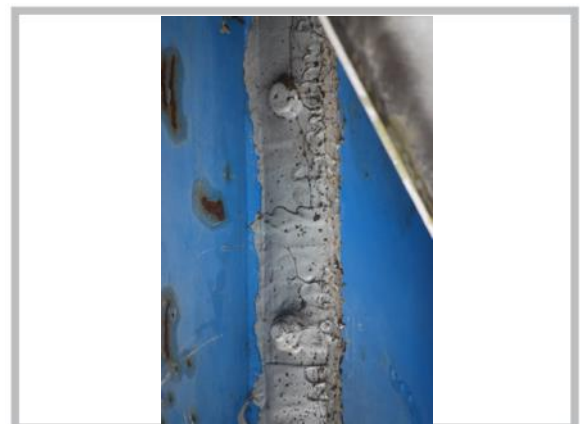
During this site visit we used a strong telephoto lens to take better quality images. As you can see, Oxifree TM198 is still in excellent condition and is providing full protection against corrosion almost 4 years after the initial applications.
