Protecting flanges onshore

Case Study

Protecting an onshore processing plant from further corrosion

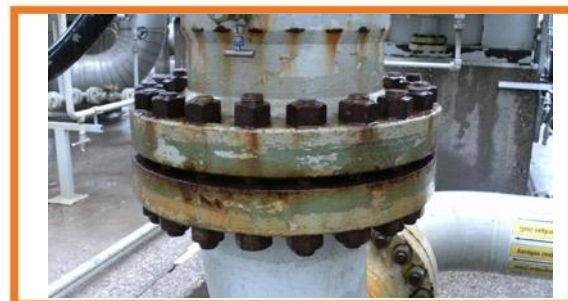
The extent of corrosion can clearly be seen before application

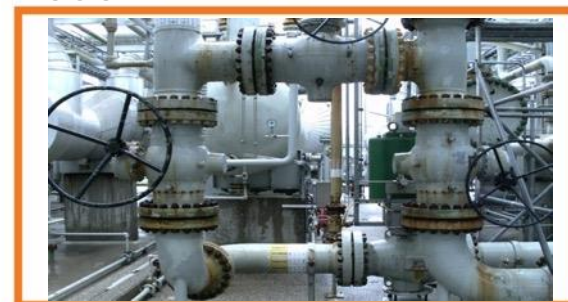
Before

NGT were experiencing significant corrosion problems due to their close proximity to the coast. Corroded equipment is clearly visible on their equipment across the plant. Our representative were called in to protect an initial 155 flanges for varying sizes with Oxifree TM198.

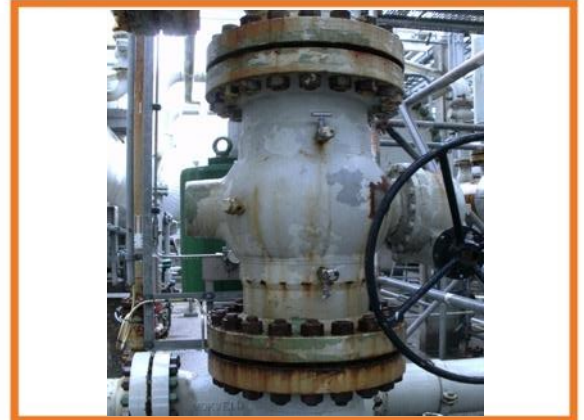
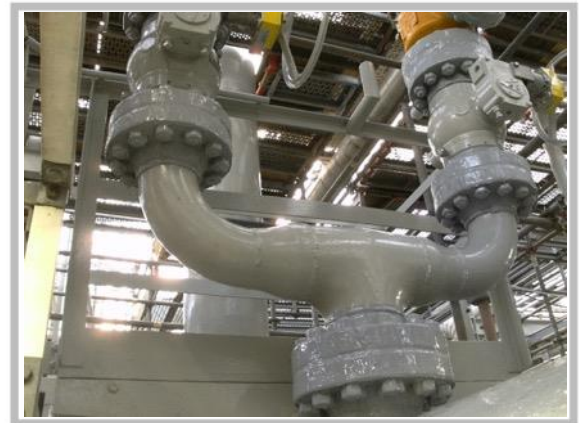
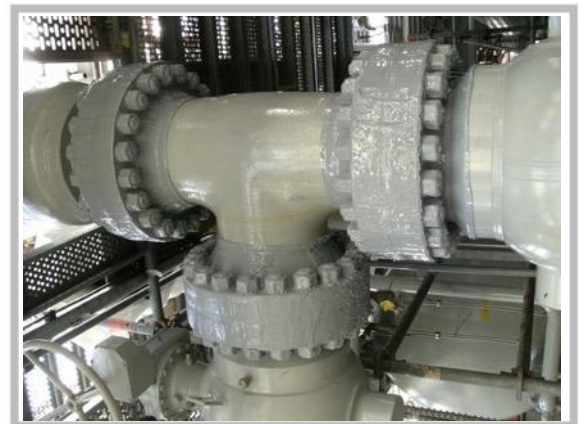
The scope of work was increased to accommodate further corroded assemblies

Whilst working on site, our representative recommended that further flanges be protected which showed visible signs of corrosion. This would ensure protection of the equipment and ensure the flanges remained fully operational. These were the additional 42 flanges that were coated over the course of the project, bringing the project total to 204 flanges.
