Application trial in a fractionation plant

Case Study

## Coating of a flange to demonstrate the effectiveness of Oxifree TM198

Location	CPQ Cangrejera, Coatzacoalcos
Local Environment	Onshore
Date	June 2014
Condition	Dry, Windy
Total Coatings	1
Substrate Type	Flange
Duration	1 day

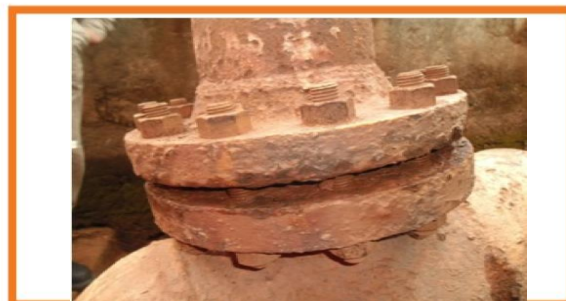
After

Flange 8 "600 # in the Cangrejera Pipeline Sector was found to be heavily corroded with rust and paint cracking. It was decided that the areas should be cleaned of all contaminants including grease, and prepared for the application of Oxifree TM198.

*The corroded condition of the flange can be seen below prior to cleaning and application.*

The area was cleared of contaminants and degreased using an eco friendly degreaser solution along with wire brush, spatula and sanding to speed up the process.

Oxifree TM198 was applied to the recommended thickness of 4mm which has a dielectric coating and protection of 60 KV. This dielectric protection is an additional advantage for Site Safety.

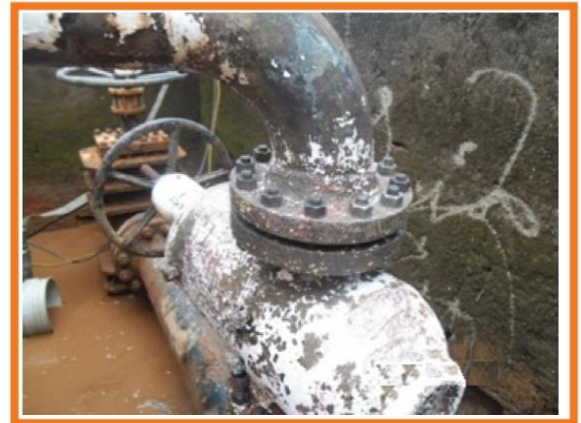
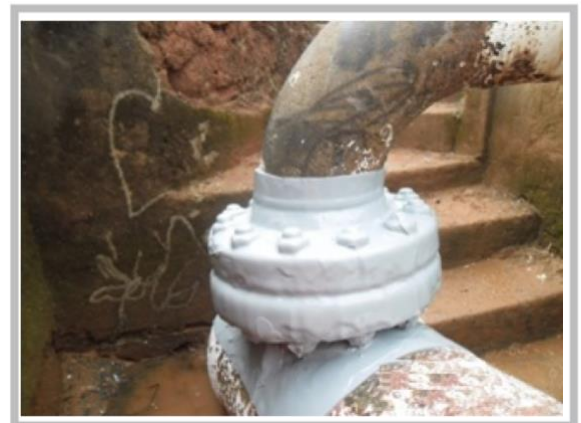
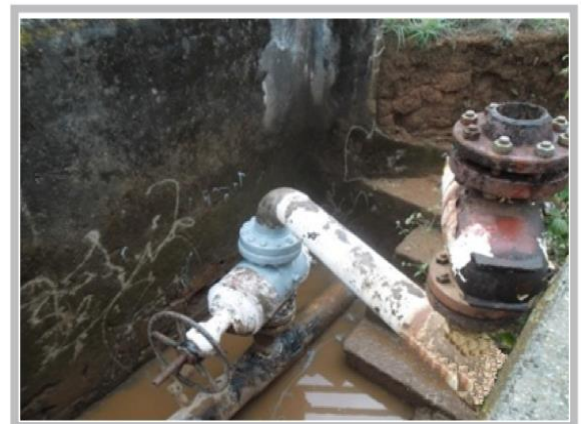
In May 2015, a year after application, the site was revisited and the coating removed (without damaging the substrate). The protected flange and bolts were in the same condition they were before coating. The inhibitor oil is clearly evident and the whole site free of advancing corrosion.

*The application would be revisited after a year.*
