**Dŵr Cymru**  
**Welsh Water**

**END OF JOB REPORT FOR OXIFREE  
COATING ASSETS  
BRITHDIR MAWR RESERVOIR  
FEBRUARY 2019**

Orbis asset Integrity Ltd  
12 Wilkinson Business Park  
Clywedog Road South  
Wrexham Industrial estate  
Wrexham  
LL13 9AE

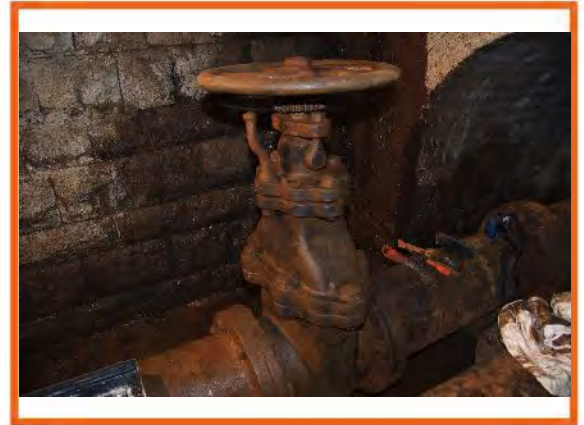
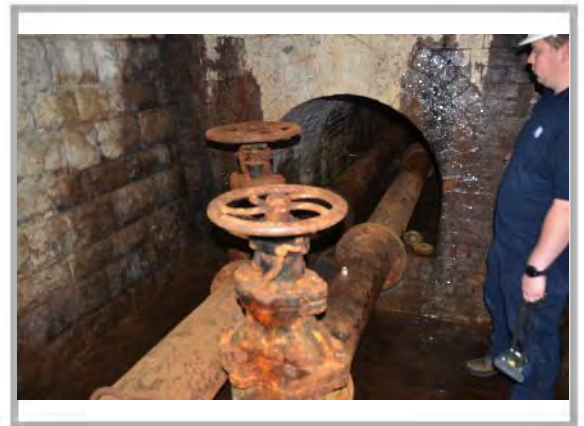
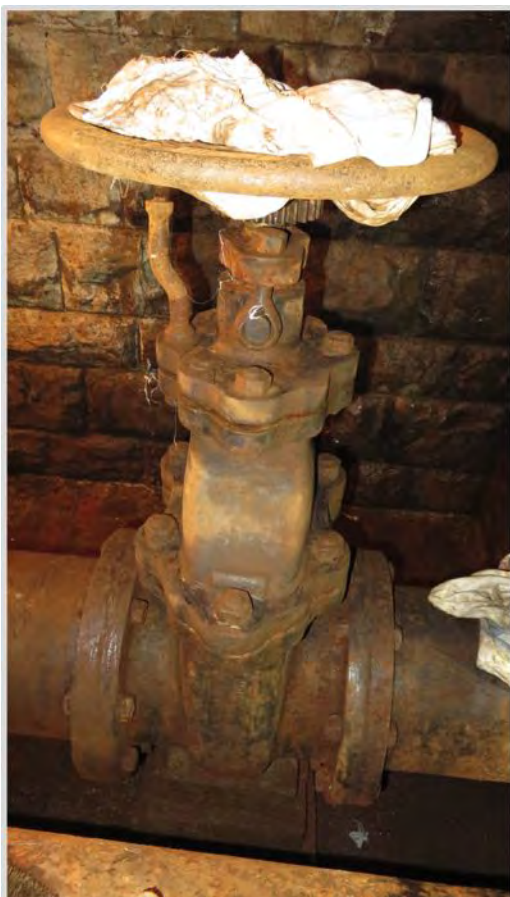
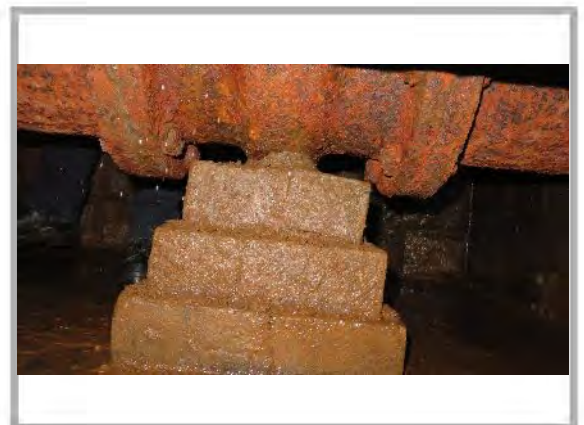
Both valves to be coated were closed because when opened and cold water flowing through condensation formed on the outside. The valves were wire brushed and compressed air used to blow the surface rust away. This is one of the major properties of Oxifree where only loose particles of rust have to be removed and not be subjected to blasting down to bare metal. The natural leeching of oil from the product contains an inhibitor which prevents any further corrosion along with the fact that oxygen is removed when the encapsulation takes place. It can be seen in the photo at the bottom right, the upper concrete plinth which was coated along with the valve and flanges.

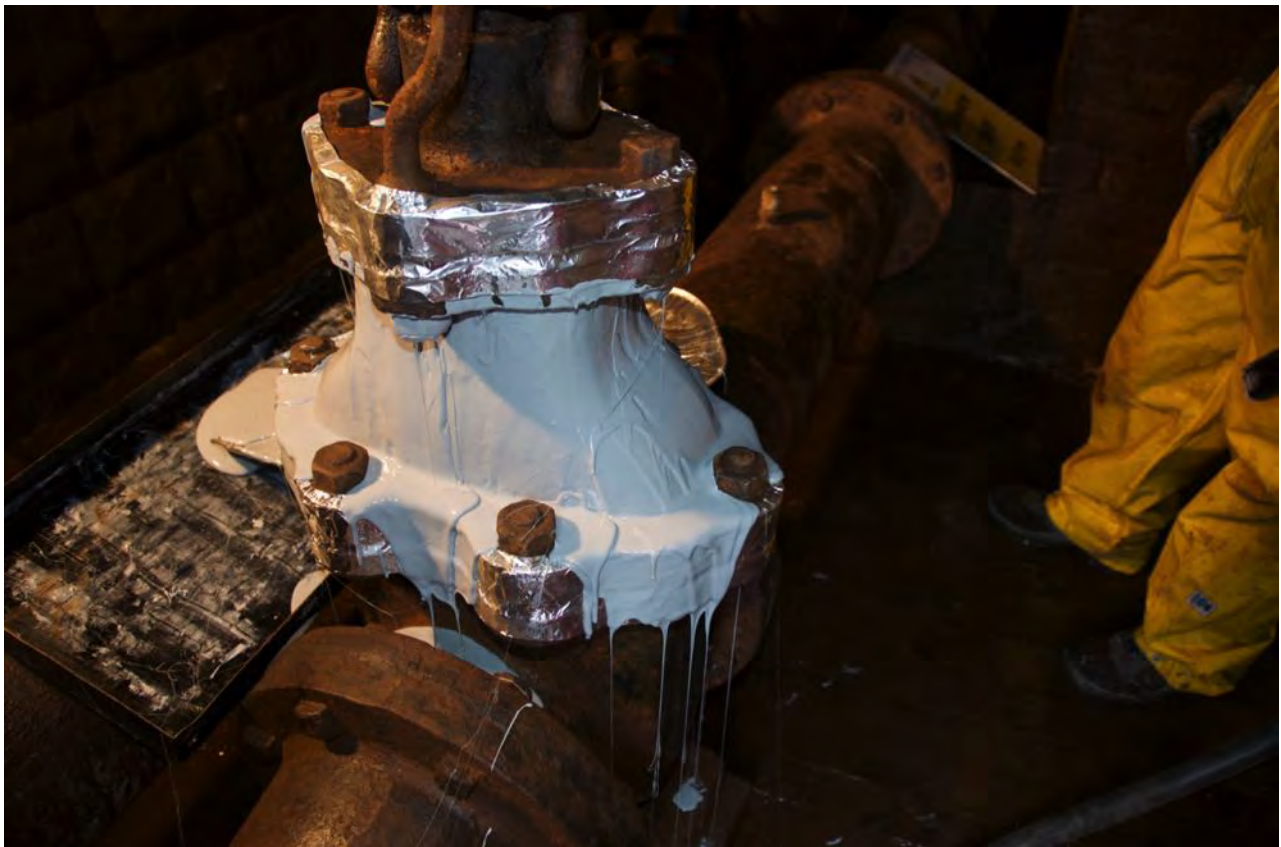
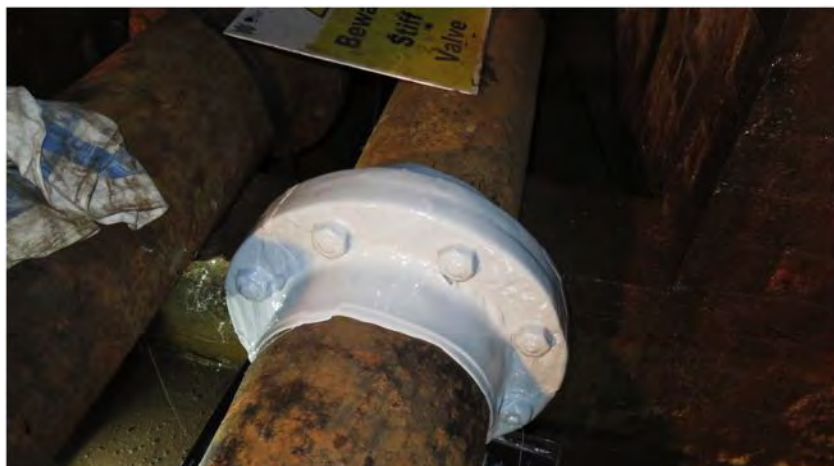
Once the surfaces of each of the valves and flanges were dried and cleaned, coating operations began. One of the valves we were going to coat fully to include the flanges on each side. The other valve we only coated the body and left the flanges uncoated. This was to have a comparison to work to. The flange in the background of the photo below was also to be coated.

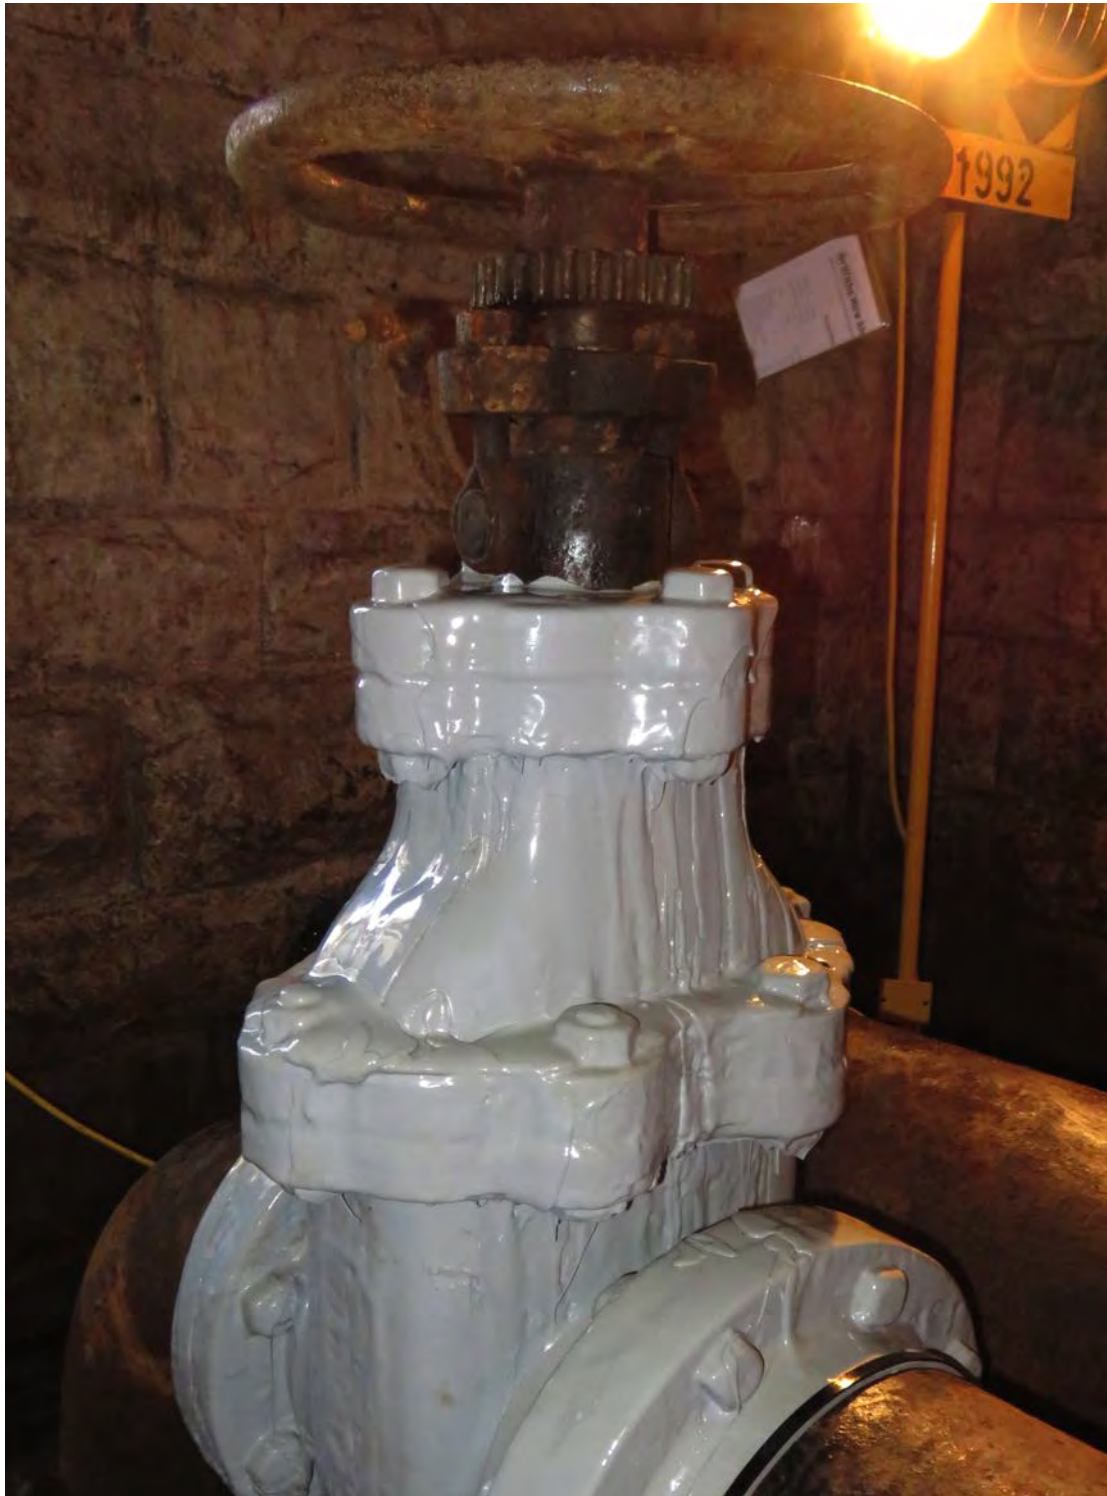
Below Photograph shows the fully coated valve and flanges

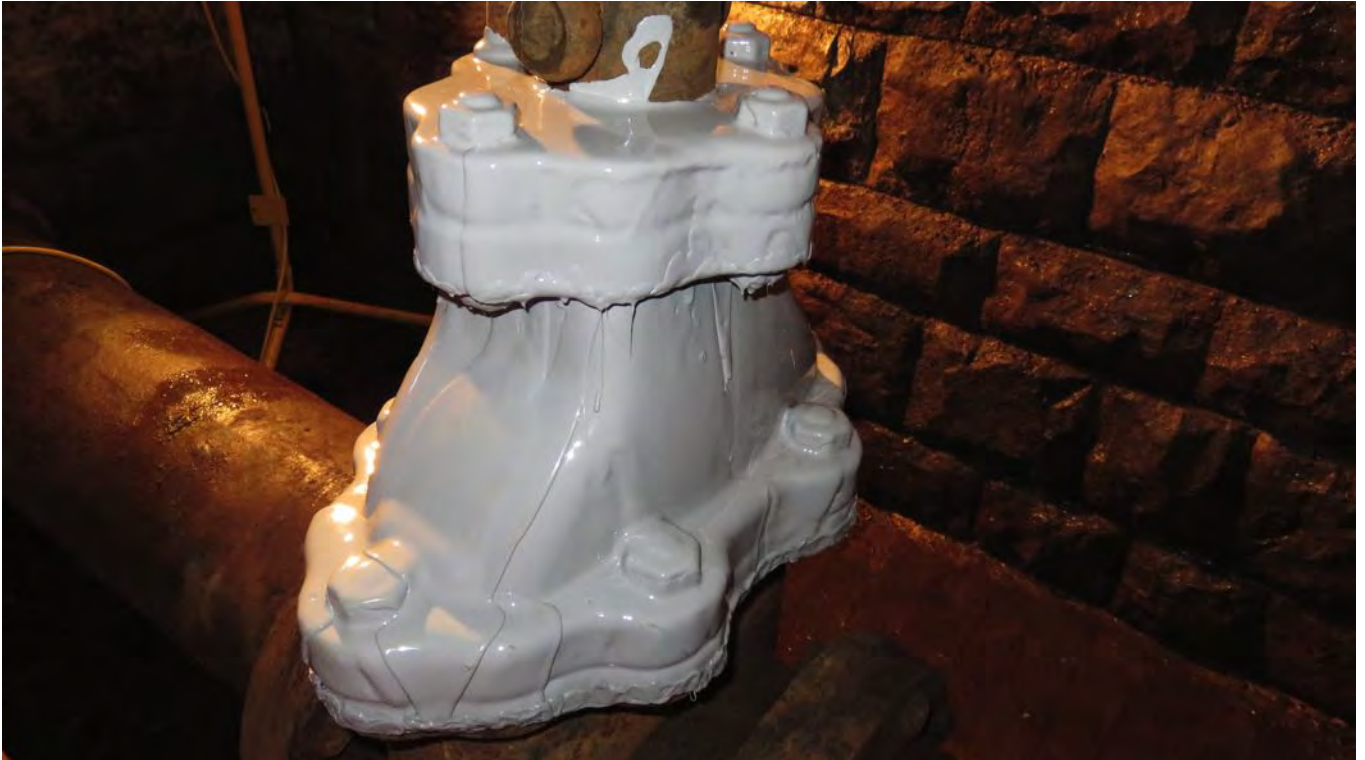
The above shows the part coated valve without the coated flanges

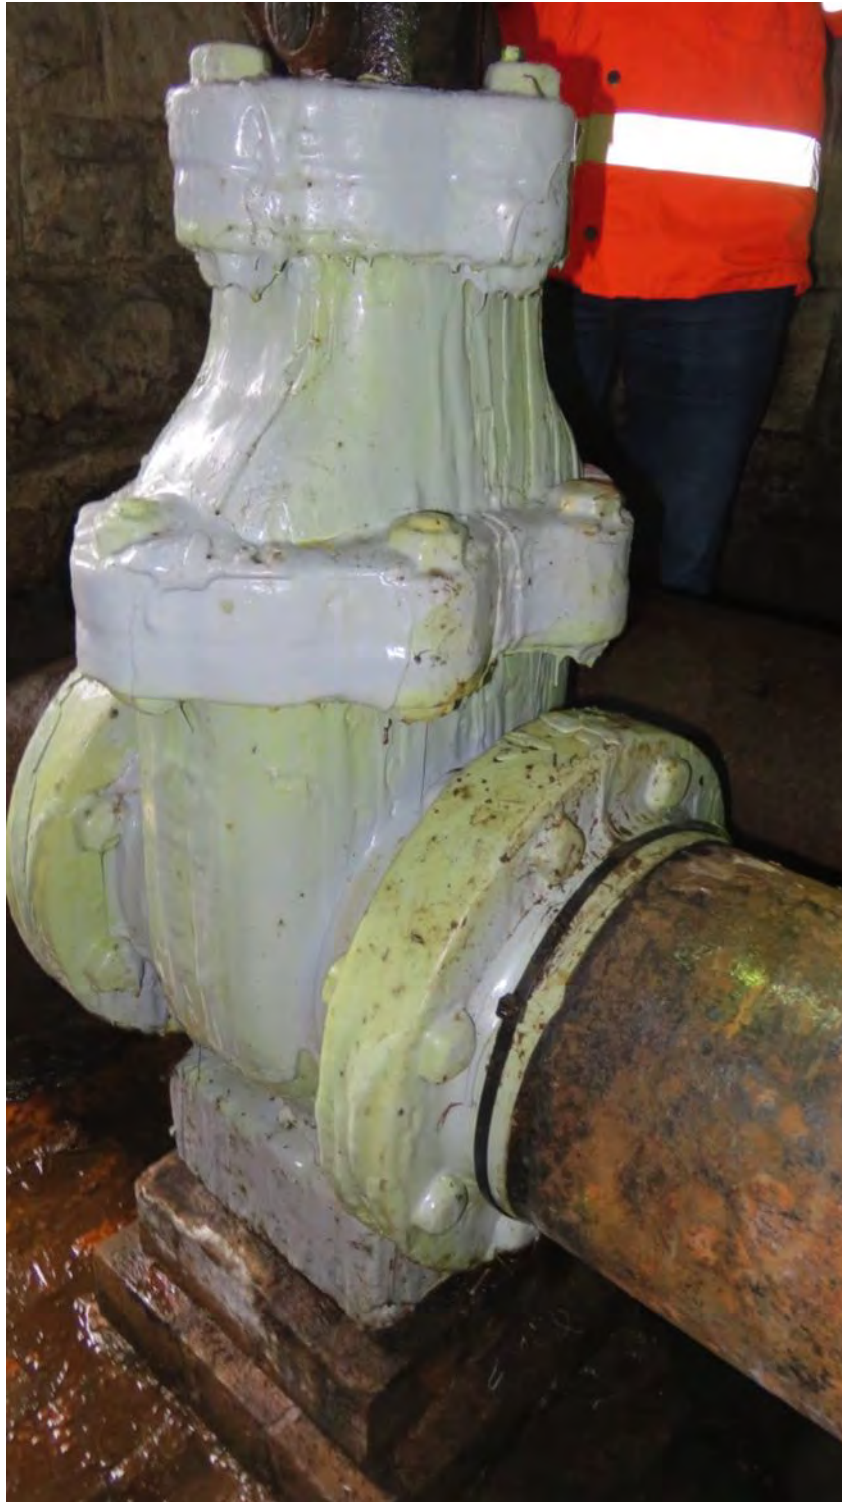
Below are a series of photos showing the assets as found when entering the chamber on 20<sup>th</sup> February 2019-02-26

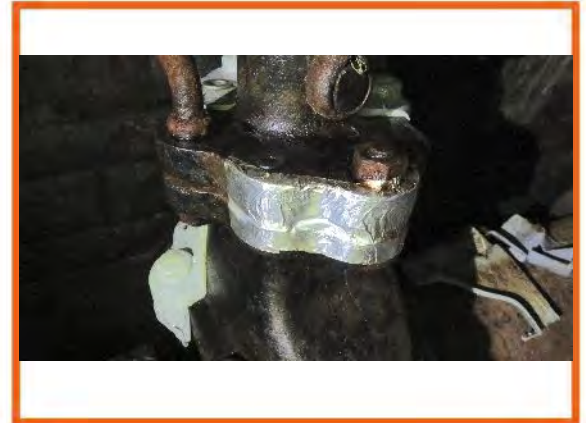
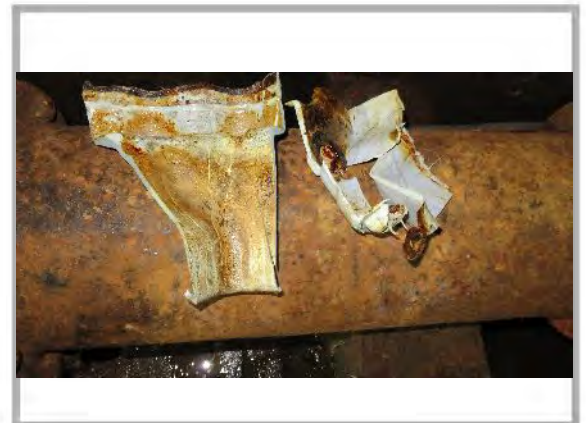
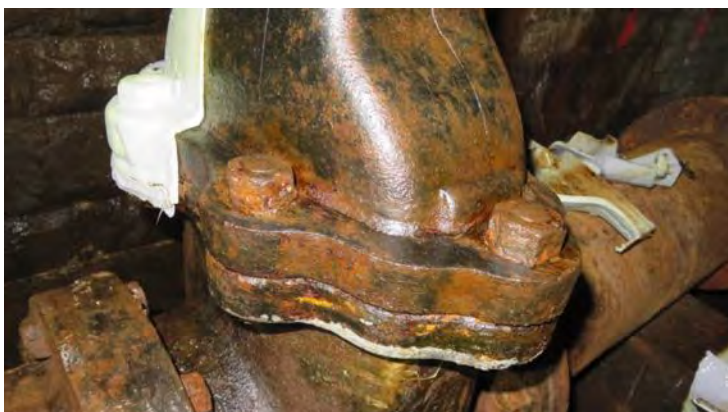
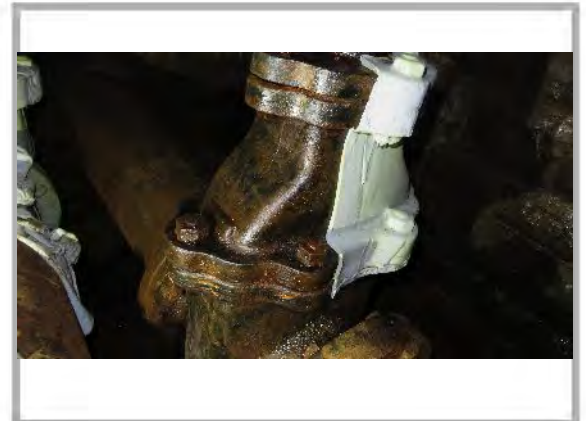
One of the questions brought up was why the inside of the removed coating was stained brown. This is easily explained by the fact the surface of the assets were corroded and we only lightly wire brushed to remove the loose contamination. There was still corrosion present and the inhibited oil within the product has dissolved some of the remaining corrosion. If the assets had been blasted to clean metal or they were brand new then there would be no staining.

One can see by the coating that the surface was showing slight contamination and the surface was slightly oily. The oil within the product leeches out naturally as this a barrier to prevent moisture and any other contaminates ingressing.

One can see by the photos that there is a film of oil on the surface of the valve once the coating was removed.

A quick wipe over with a cloth removed most of the surface contaminates.
