## Concrete “Muff” Corrosion Protection Case Study

## Concrete “Muff” Corrosion Protection

Location	Scotland
Local Environment	Electricity Substation
Date	September 2014
Condition	Dry
Total Coatings	1
Substrate Type	Concrete “Muff”
Duration	1 Day

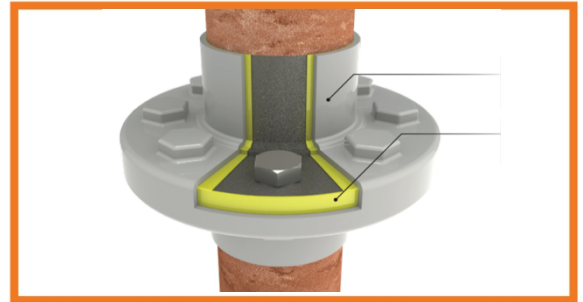
Oxifree TM198

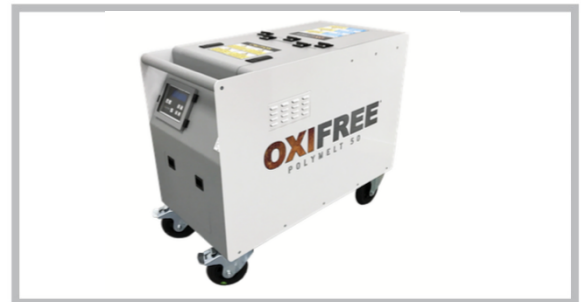
Polymelt 50 Application Machine

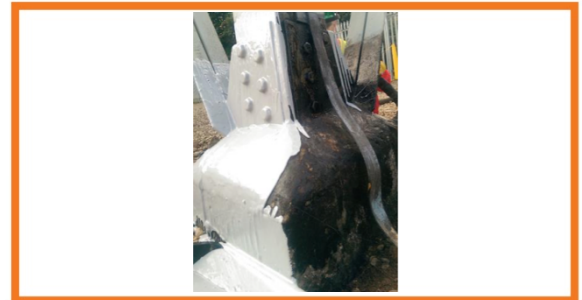
During application of Oxifree TM198

The area was excavated to a depth of 120mm around the concrete then cleaned with water only. Once dry, Oxifree TM198 was applied to the pylon upright and support beams and down onto the concrete. An application of silcon was applied to the leading edges to make tamper proof. The complete project took 4 hours.

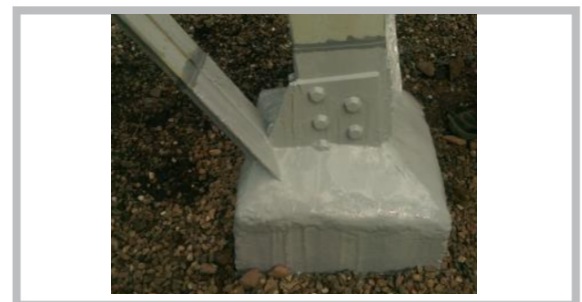
Concrete “Muff” after TM198 application
