SF6 Gas Release Repairs
Case Study

SF6 gas release solution

Location	Peterhead
Local Environment	Power Station
Date	July 2014
Condition	Dry
Total Coatings	16
Substrate Type	Circuit Breakers
Duration	3 Days

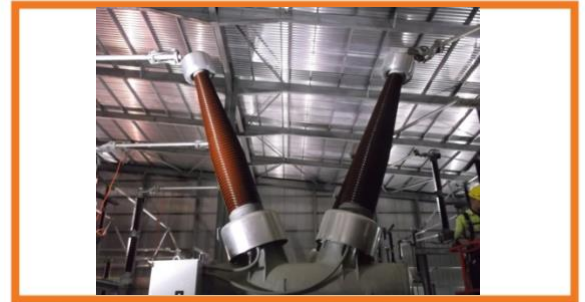
Before

The first step was to fully understand the nature of the leaks. After years of vulnerability to the environment and pollutants, the interface between the ceramic and aluminium support became porous and had allowed exertion of the contained SF6 gas.

The agreed solution was for Oxifree to firstly apply Oxifree repair putty to the leaking area, apply the repair wrap and then to apply two layers of Oxifree TM198 to give an overall thickness of approximately approx. 4mm.

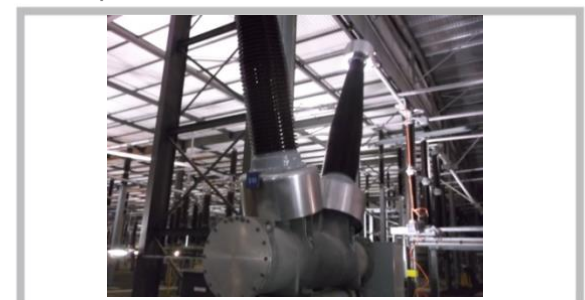
Complete

The project was completed in good time and the SF6 gas leak was fully arrested.
