Oxifree Case Study Food Processing

Location: Vale do Ivai (Sugar and Alcohol Industry)

Date: 08/24/2009

To prove the efficiency of Oxifree within the Sugar and Alcohol producing industry.

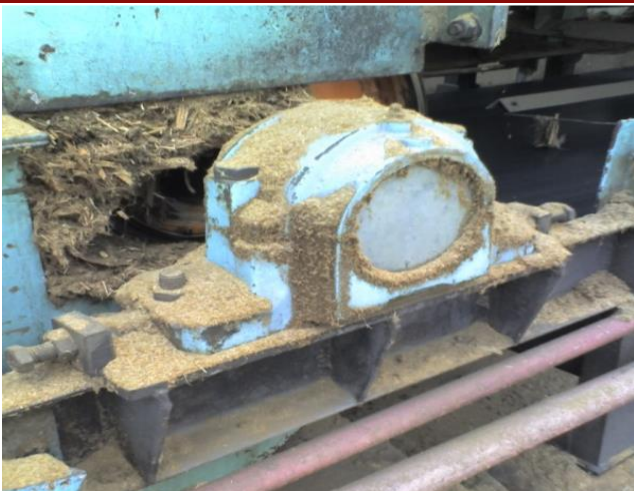
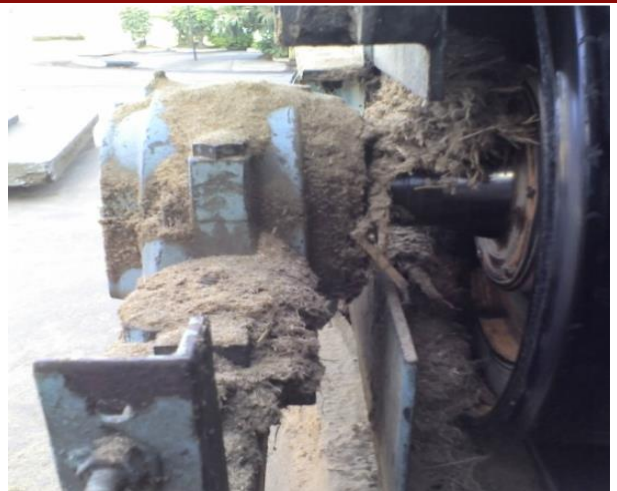
The pictures below show the regular operating conditions of the bearing house without the protection of Oxifree.

Dust particles are able to penetrate the unit damaging it and reducing its useful life.

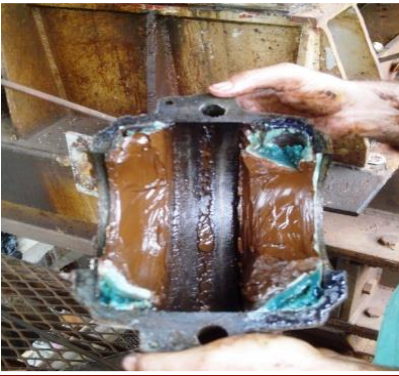
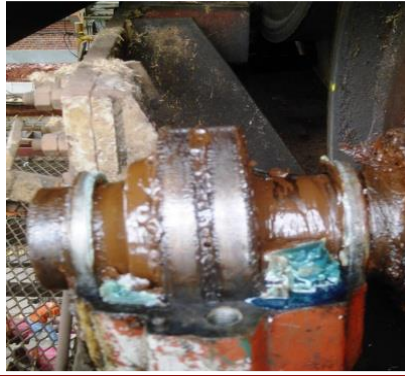
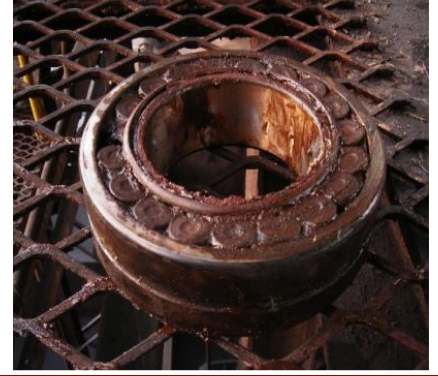
This contamination was due to particles penetrating deep inside the housings resulting in the bearing houses being replaced 2-3 times during the season of production, therefore generating substantial operational costs.

The pictures below show the effects the regular operating conditions (without the protection of Oxifree) have on the bearing house with less than 6 months of use. Note how contaminated the grease becomes.

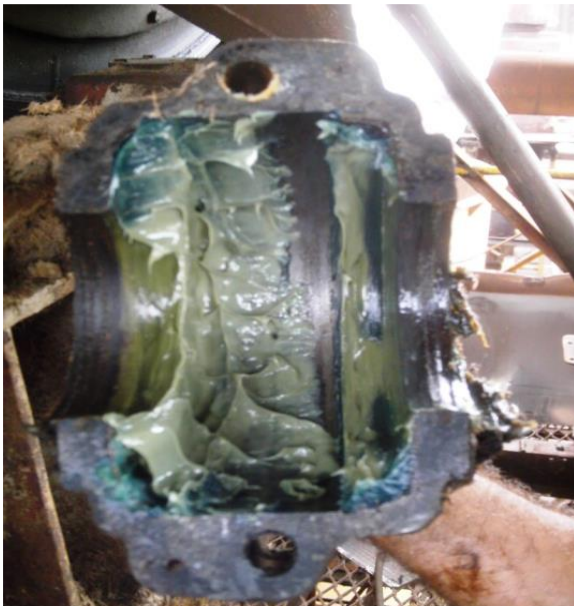
The pictures below show the test bearing protected by Oxifree after one season of use. The bearing was replaced at the same time as the one shown above.

Clean grease (no contamination)

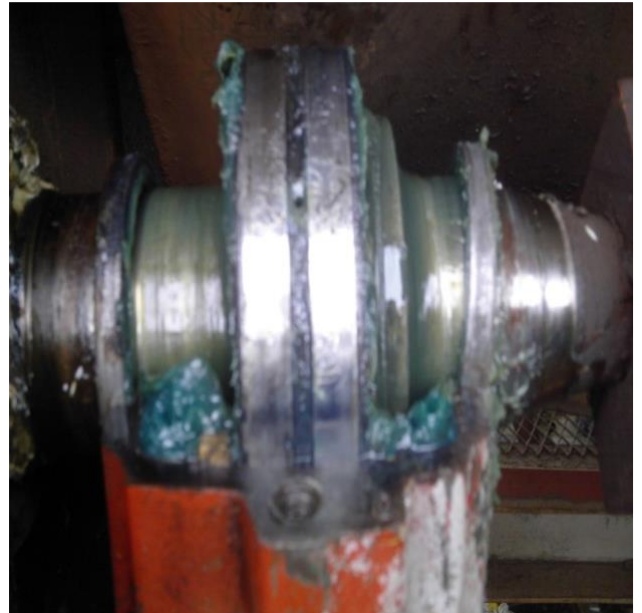
After one season of regular use no particles were found and there was no need for part replacement.

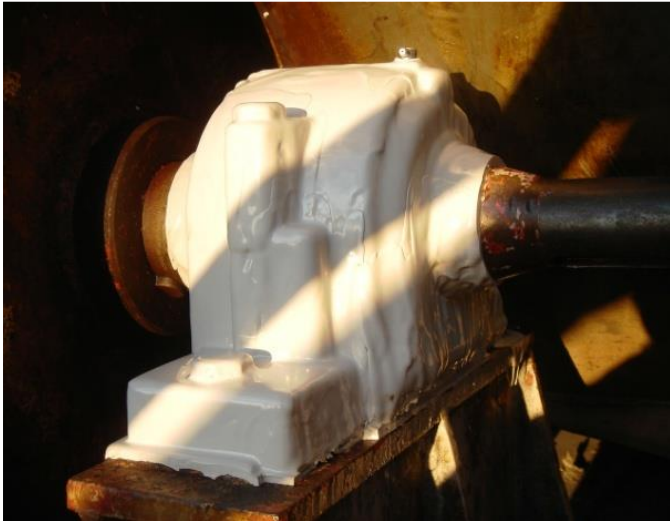
The unit after cleaning, parts replaced and Oxifree applied

Two test units (bearing housings) were opened to be serviced and refurbished. One bearing was reassembled and left as normal, the other was reassembled and applied with Oxifree polymeric resin protective coating. This served as a test study for the efficiency of Oxifree as a shield to the ingress of foreign elements. Both units returned to work.

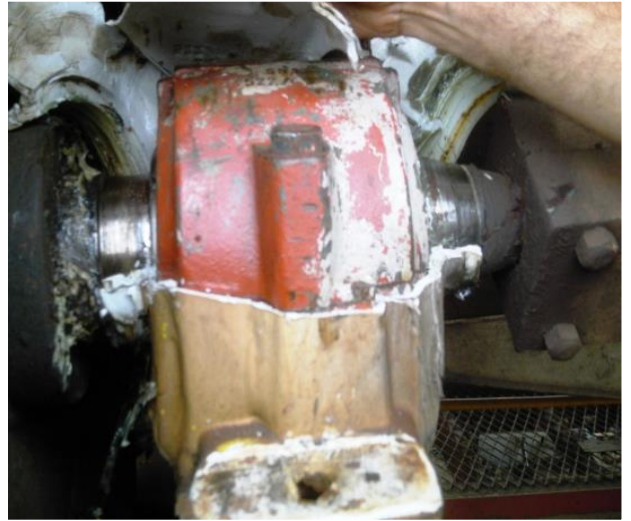
The unit being opened at the end of the season of Oxifree protection

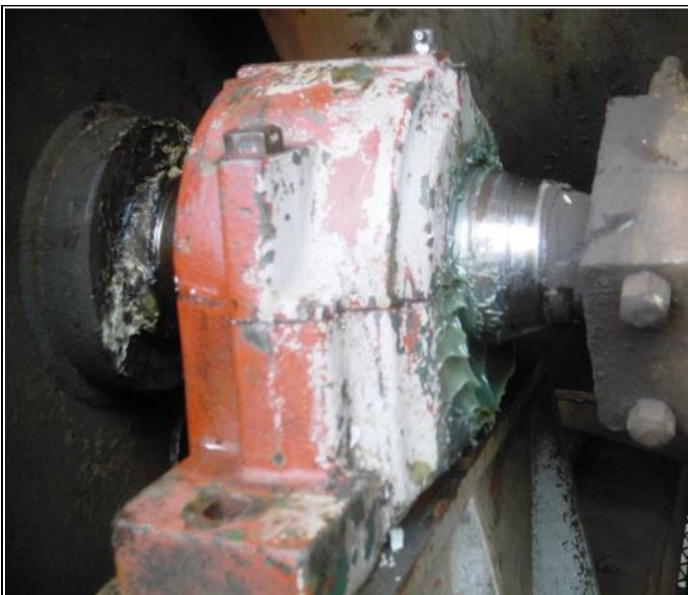
The unit after removing the Oxifree protective coating

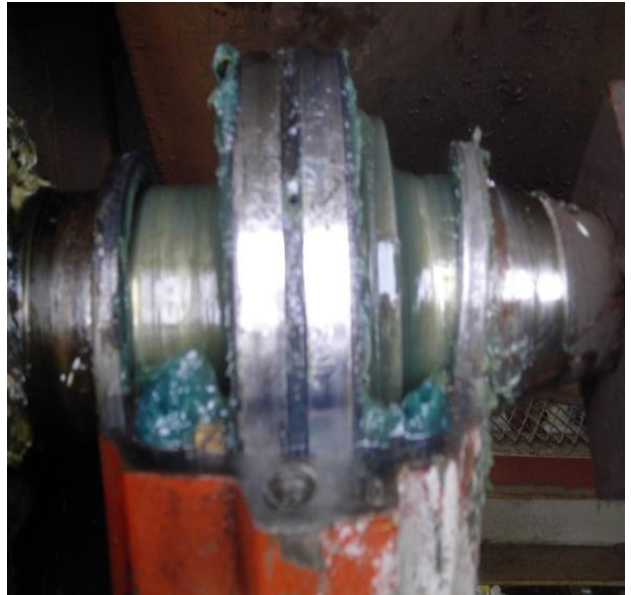
The bearing shows no evidence of contamination

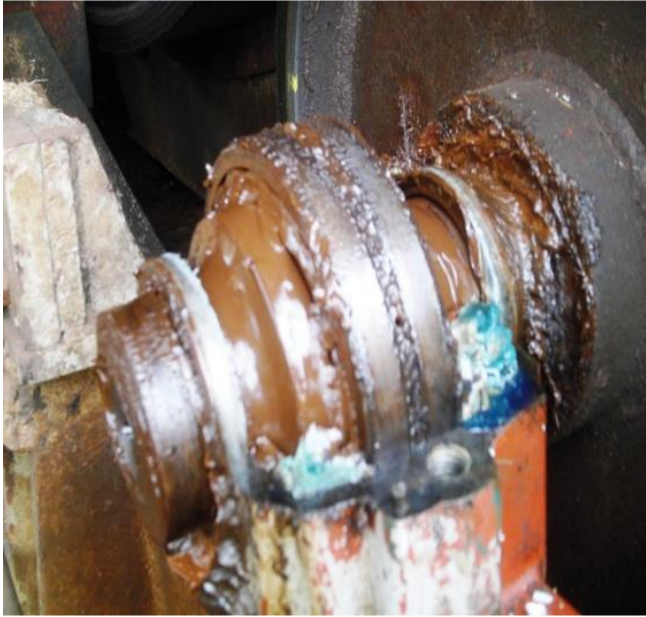
Less than 6 months later the clients' maintenance team opened the test unit without Oxifree and found lots of particles and contaminants in it (see left image).

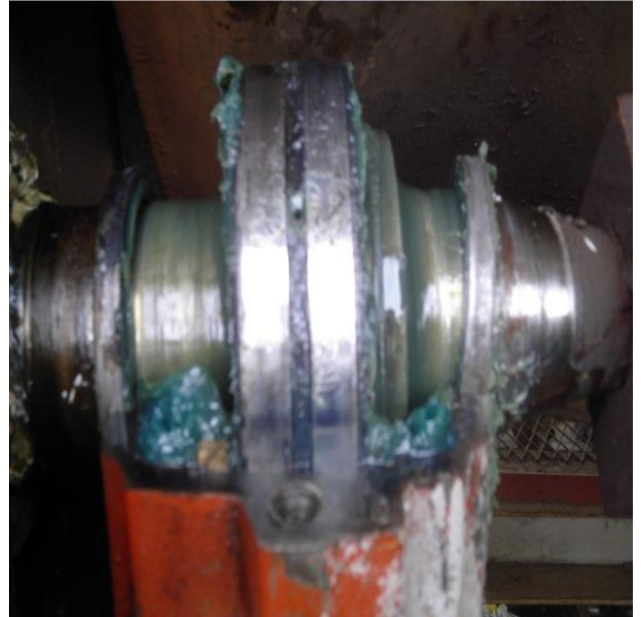
For the unit protected by Oxifree they waited a whole season (approx. 1 year) and opened the unit to find the internals clean and no dust ingress to be evident (see right image).

The grease inside the unit protected by Oxifree was clean and the bearing was in great operational condition.
