Protecting Pipework Field Joints Offshore  
**Case Study**

## Eliminating unplanned downtime by protecting pipeline weld anomalies whilst in service

Location	Britannia Platform
Local Environment	Offshore Platform
Date	February 2016
Condition	Cold, Dry
Total Coatings	9
Substrate Type	Pipework Anomalies
Duration	2 Days

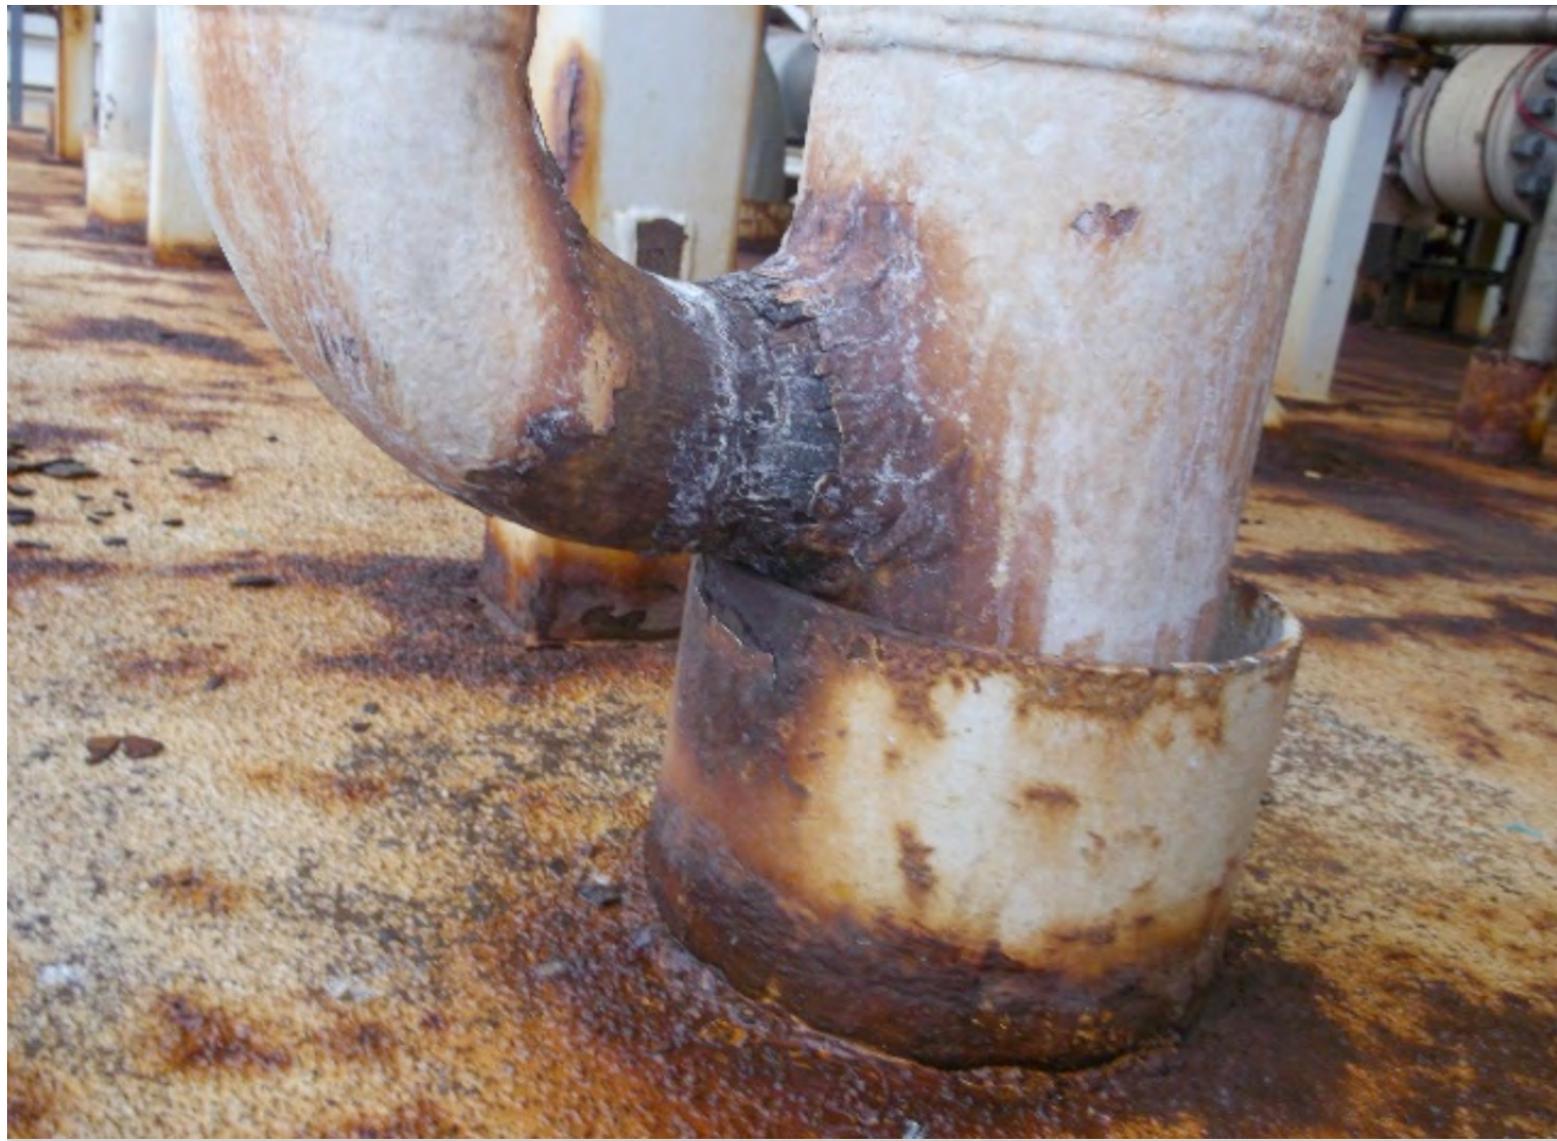
*Condensate pipeline weld anomaly corroded prior to application of Oxifree TM198*

Oxifree TM198 was selected as the solution as it required no surface preparation. Oxifree TM198 was applied to the anomalies to halt corrosion and maintain the integrity of the pipework until it could be replaced during a convenient shutdown, avoiding an unnecessary shutdown.

Following the minimal surface preparation (brushing loose corrosion away with a wire brush), a 3mm coating band was applied around the pipework completely covering the corrosion anomaly. Once cured a cable tie was attached on top of the Oxifree TM198 material at the ends with a second 3mm coat being applied on top. This extra protection to the ends of the TM198 material ensures long-term protection in the harsh offshore environment and stops the ingress of water and other contaminants.

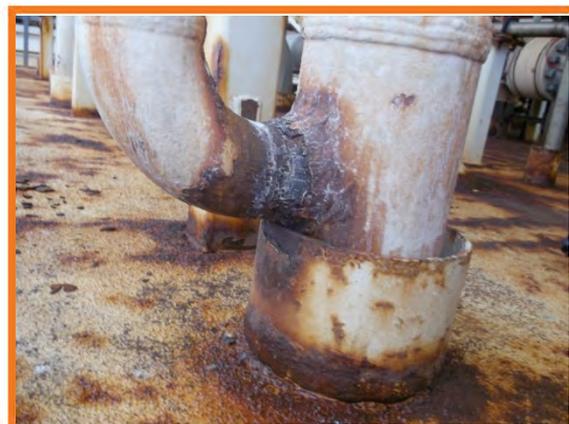
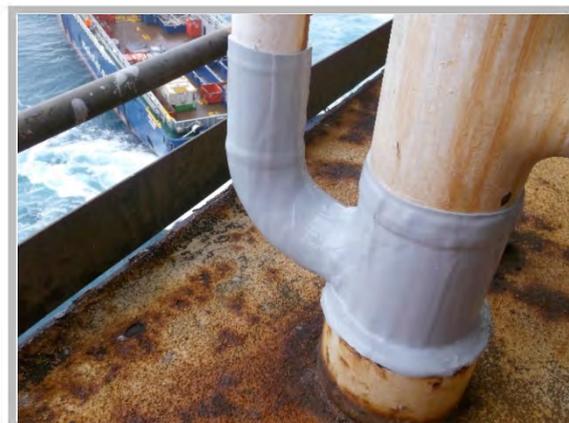
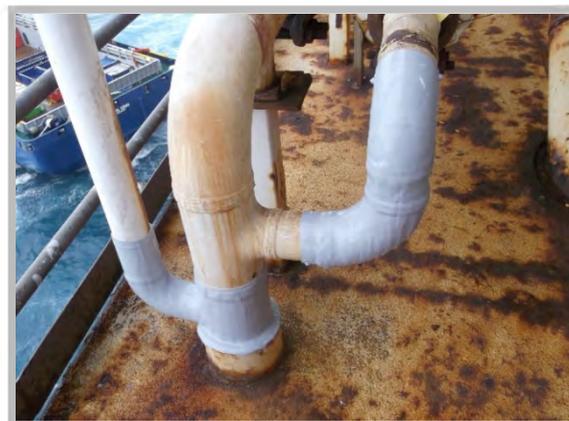
*Condensate pipeline weld anomaly corroded prior to application of Oxifree TM198*
