## Phenol Pipeline Flange Protection - Singapore Case Study

Location	Singapore
Local Environment	Onshore
Date	11-12 October 2017
Condition	Dry
Total Coatings	13 flanges
Substrate Type	Flanges
Duration	2 days

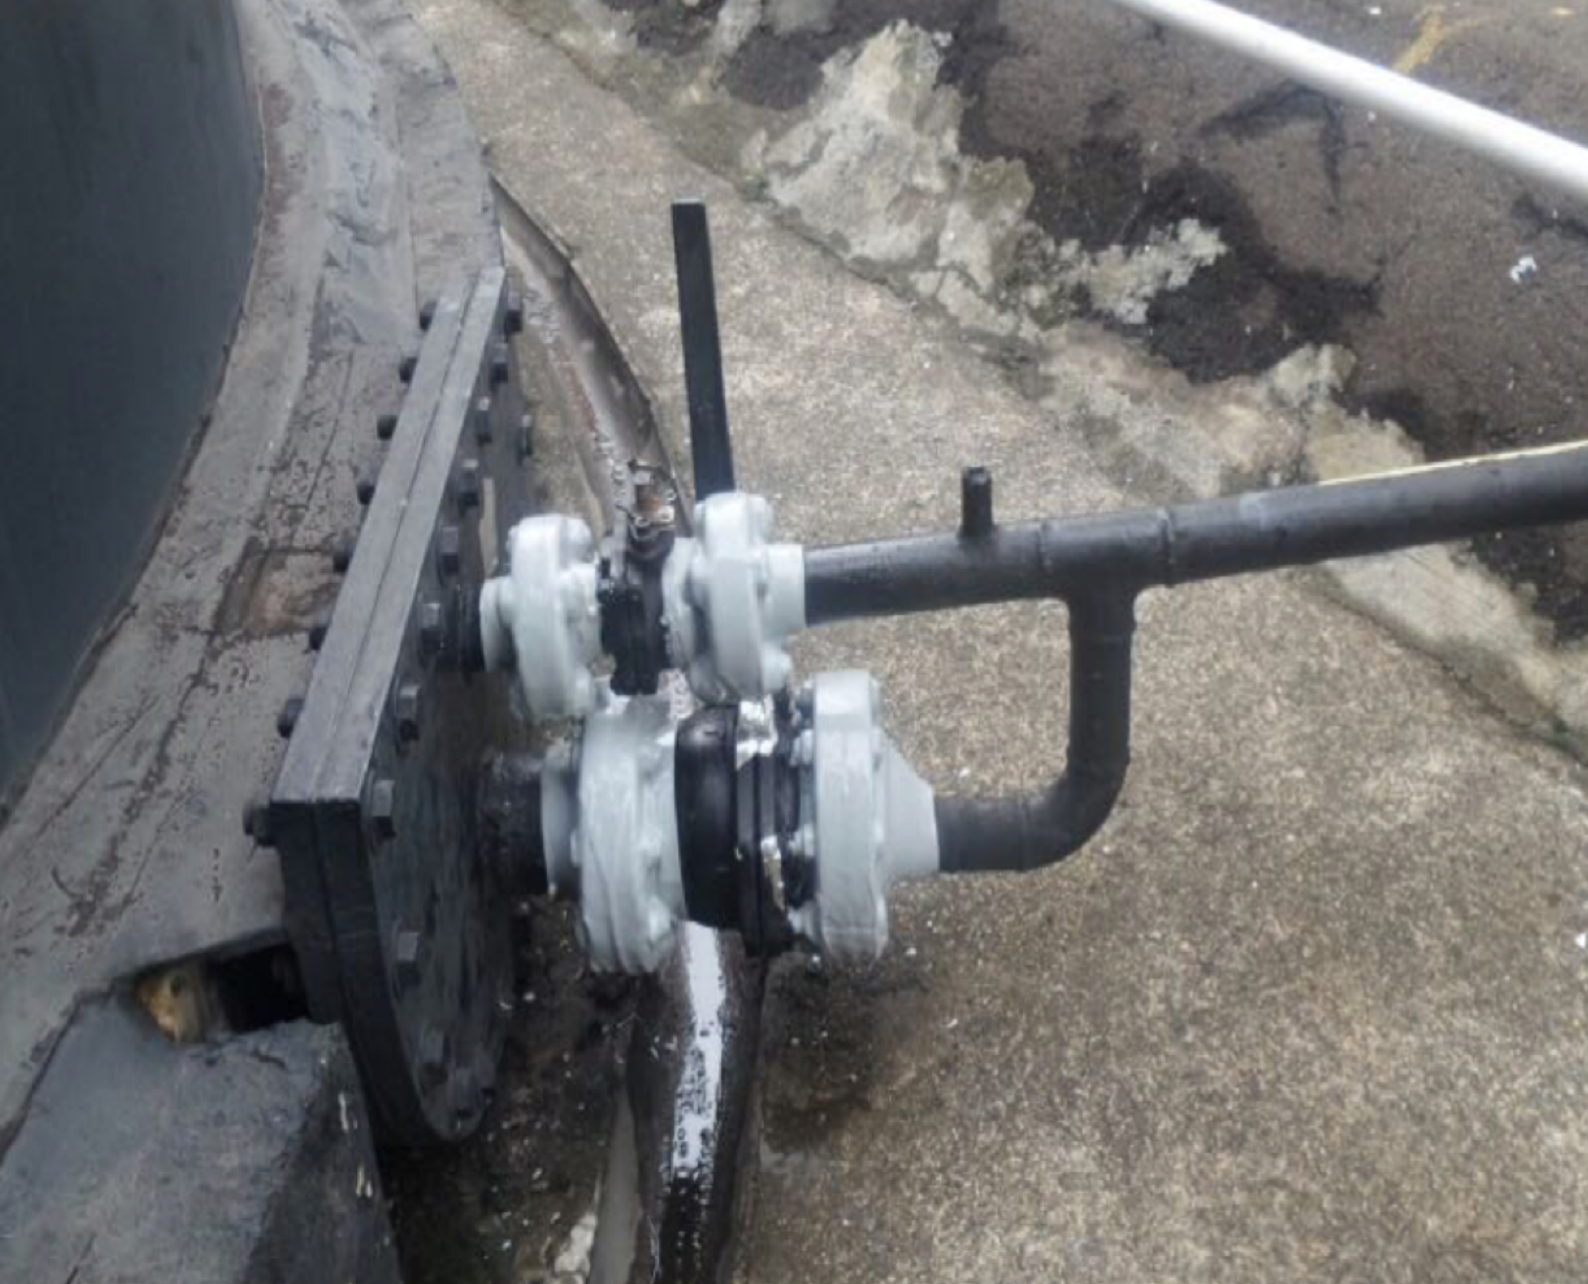
*Before and after coating of application*

Oxifree TM198 was used to protect 13 flanges onshore in Singapore. The 13 flanges had suffered extensive corrosion on the phenol lines due to the environment. Oxifree provided the perfect solution being applied with minimal preparation and offering immediate protection. The flanges would then be completely protected from any further corrosion damage.

A team of 1 supervisor and 1 technician applied Oxifree TM198 to 13 flanges on a Methanol/Phenol pipeline in a Zone 2 hazardous area. Surface preparation was minimal, a wire brush was used to remove the loose debris. No degreasing or blasting was required which is advantageous in such a hazardous environment.

A total of minimum 4mm coating thickness was achieved to protect the asset from further corrosion and contamination.

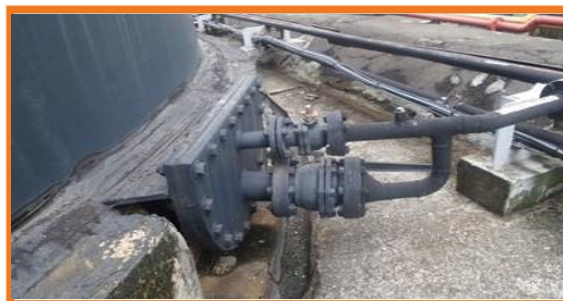
Mun Siong were asked to coat 13 flanges ranging from 2" to 6" with Oxifree TM198. After inspection a few flanges were discovered to be more severely corroded, this did not prove a problem for using TM198.

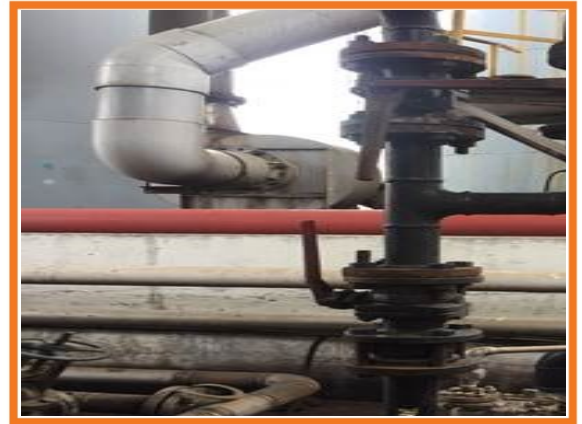
The Polymelt 50 ATEX Machine was used which is rated for use in Zone 2 environments. A 15meter hose was used within the congested area due to the limited access areas.

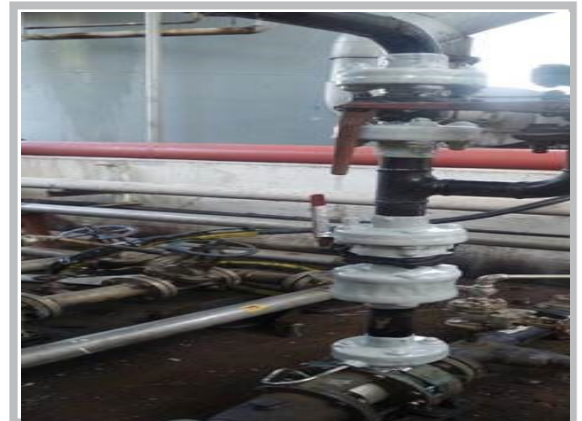
13 flanges with sizes ranging from 2" to 6" were coated with Oxifree TM198. The coating provides immediate protection against corrosion and contamination. The client was very happy with the speed of application and overall solution which was much quicker than the previous approach of blasting and painting.
