## Protecting equipment in a Chlor-Alkali unit. Case Study

## Protecting flanges and valves in a heavily corrosive environment.

Location	Alagoas
Local Environment	Onshore
Date	6-22 June 2011
Condition	Dry, humidity
Total Coatings	Multiple across the plants
Substrate Type	Flanges and valves
Duration	16 days

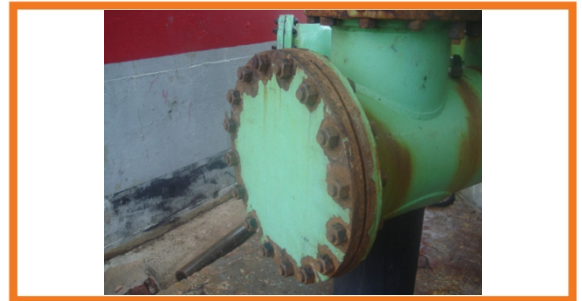
*The bolts are in a very heavily corroded state prior to application.*

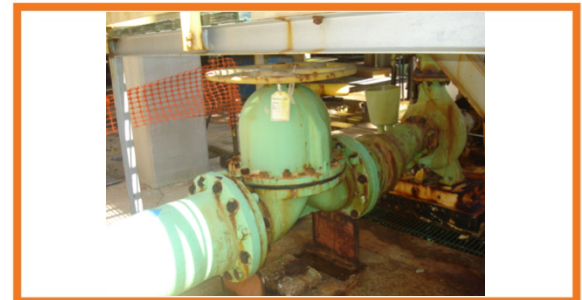
Before

TecnoFink were commissioned by Braskem to protect flanges and valves in various plants in Alagoas, against corrosion and contamination. Specifically, the equipment was located in the Chlor-Alkali unit, a very corrosive environment. In the photos you can see the extent of the corrosion to the flange and bolts before applying TM198.

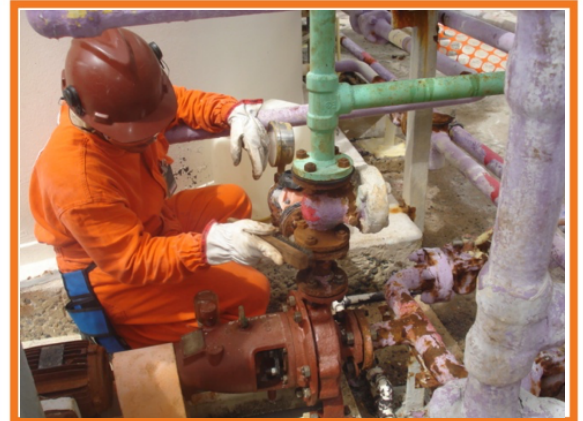
*Simple wire brushing prior to application removes any loose debris. Application was by the Polymelt 50 AI machine.*

The areas were simply cleaned of contaminants and corrosion using a wire brush.

After cleaning Oxifree TM198 was applied directly onto each of the affected areas using the Polymelt 50 AI machine for hazardous environments to a thickness of 4mm.

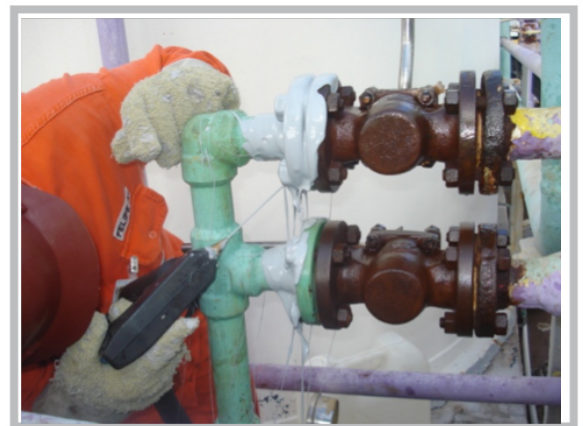
TM198 cures instantly on application and protects the equipment immediately from further corrosion.

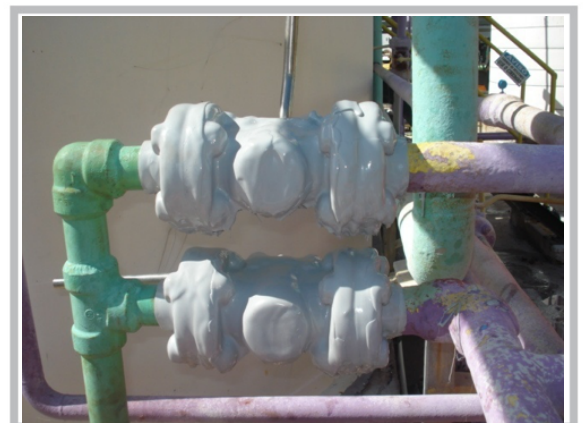
The coating was removed after 14 months for inspection. The protected areas showed no further corrosion from prior to application and the outcome was deemed a success as can be seen in the pictures.

The area which had been left unprotected showed substantial corrosion to the bolts and flange.

The TM198 protected areas were fully operational and remained as free from corrosion as the day they were protected.

*These photos show the success of using TM198, the equipment shows no signs of corrosion where it has been protected.*
