Conducting a flange trial for Lukoil

Case Study

Conducting a flange protection trial using TM198 in the Caspian Sea

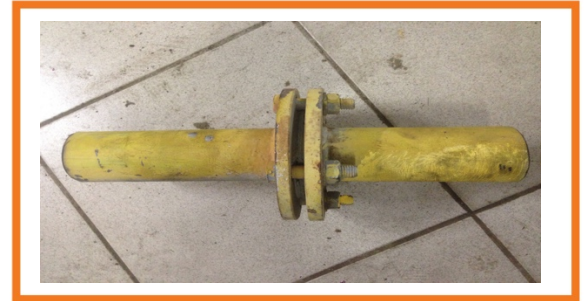
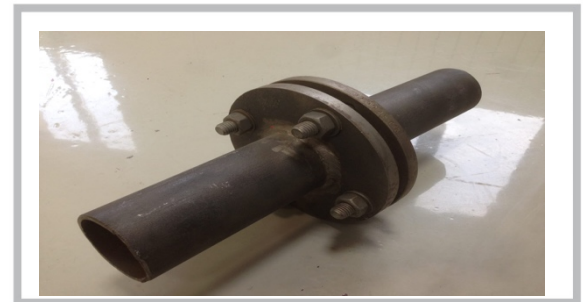
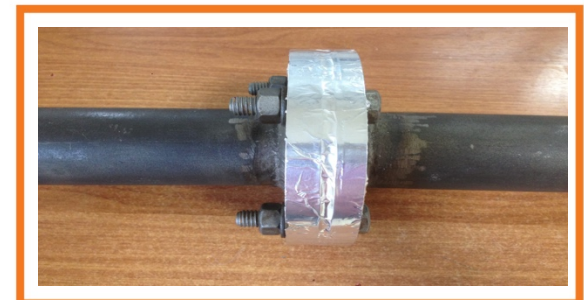
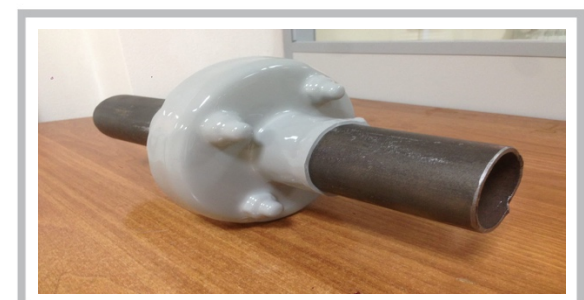
Flange photos after sandblasting and TM198 application

After

Before

A test sample (flange) was received on September 13, 2017. The flange was in good condition without significant corrosion. It had a yellow paint coating on the external surfaces.

The flange connection was processed by sandblasting at the request of the customer to remove paintwork and identify any problem areas.

Following preparation TM198 was sprayed into the flange gap to protect unblasted sections in the joint. After processing, the filled gap was additionally covered by aluminum tape. This allows for the outer encapsulation to be removed easily, for inspection after trial.

An overall layer of 4mm of TM198 was applied.

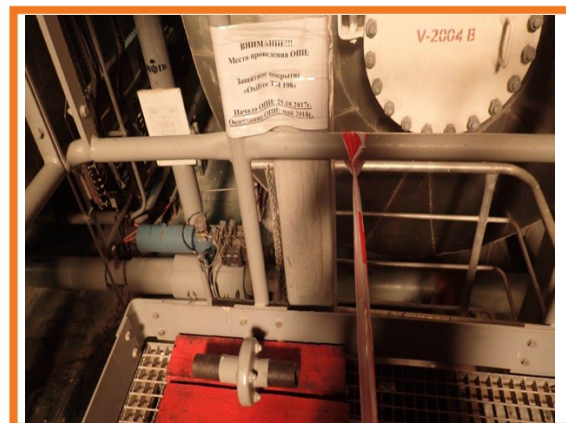
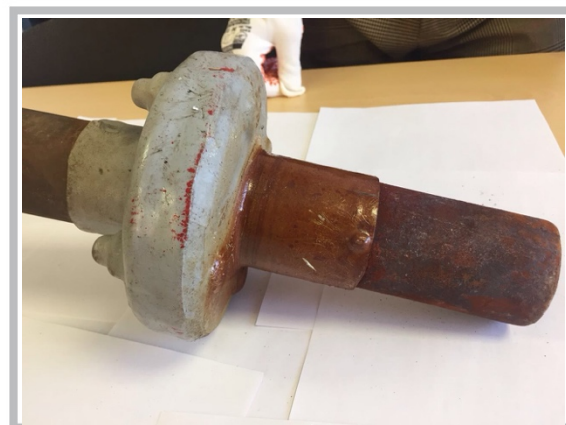
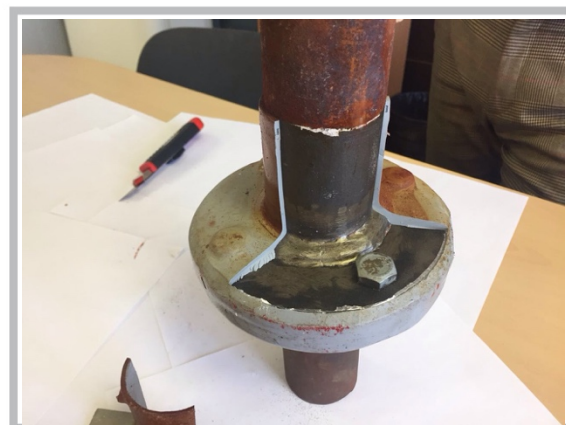
Flange photos during trial and before/after TM198 removal

Six months later, on April 16, 2018, the coating was removed. The flange was opened by a Corsol engineer at the office of LUKOIL-Nizhnevolskneft in the presence of representatives of both companies.

- The flange connection remained in perfect condition, showing no signs of degradation;
- Preservation of the integrity of the corrosion-resistant coating TM198 under the harsh conditions of the six month test;
- Absence of visible corrosion elements on both bolts and flanges after material removal;
