## Cryogenic equipment preservation

## Using TM198 to protect pipework in a cryogenic environment.

Location	Chiapas Reform
Local Environment	Onshore Gas Processing
Date	December 2015
Condition	Dry, Windy
Total Coatings	4
Substrate Type	1 Valve and 3 clamps
Duration	1 Day

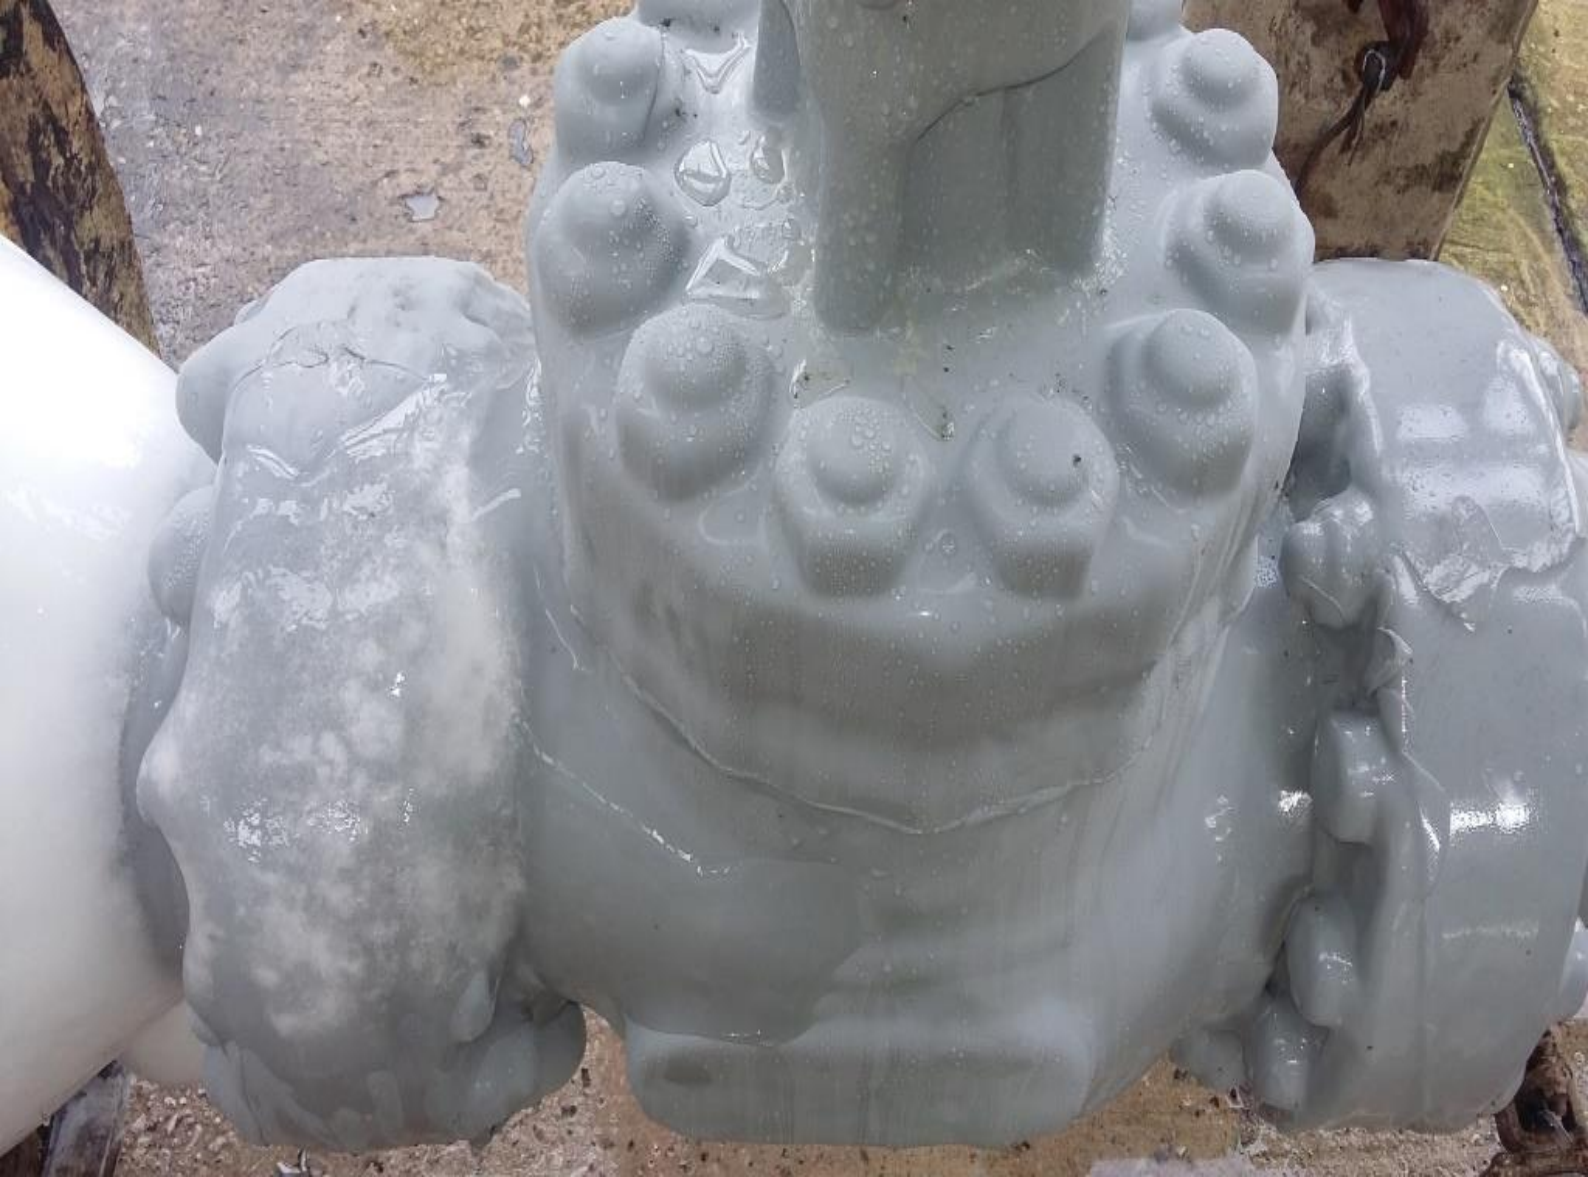
One Valve 6" 300 # EN AV - 3207 EA 3104 and Three Clamp 6" were inspected and found to have paint cracking and a high degree of rust on the surfaces. The area is subject to extreme temperature changes as can be seen from the main image where the completed coating is frozen. TM198 is able to withstand these climate conditions.

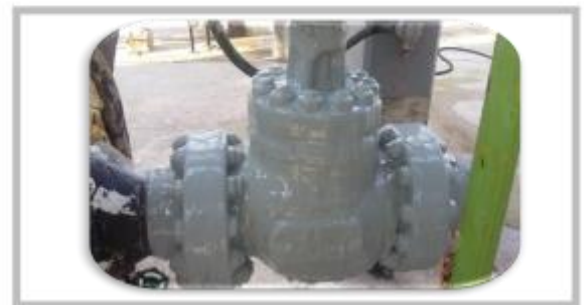
Before

*Previous paint coatings had been used but had not been successful at halting corrosion*

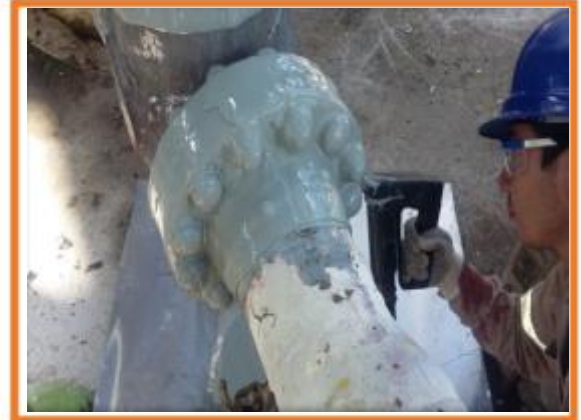
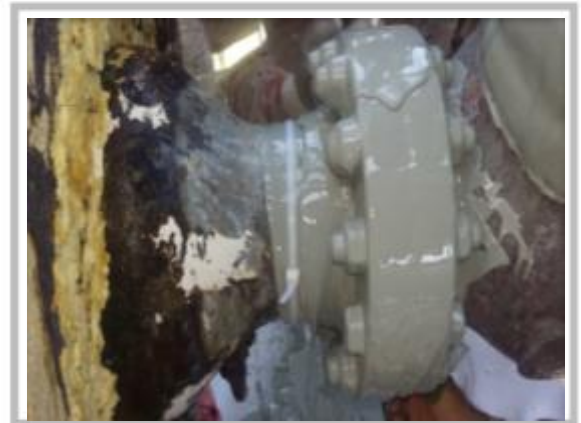
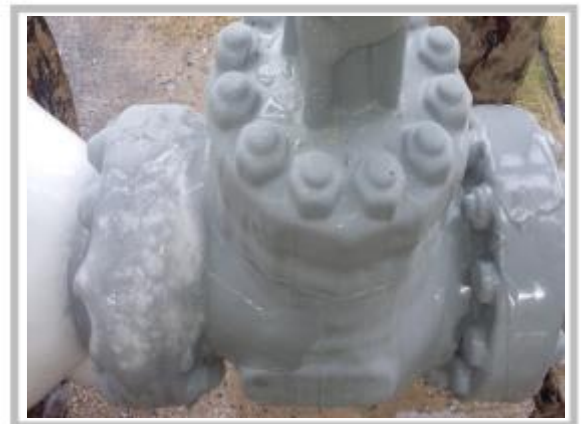
*Title of photos*

The Oxifree TM198 coating was applied throughout the body of the valve and 3 clamps to protect them from further corrosion and contaminants. The coating provides protection immediately and will provide 100% protection against further corrosion and contamination. The coating may be removed for inspection at any time.

The area was cleared of contaminants and degreased using a wire brush, and an eco friendly degreaser solution. Paint was stripped using a Carcher 3200 PSI. After cleaning, aluminium tape was applied to bridge the flange gaps, then the first layer of Oxifree TM198 was applied. The first layer is approximately 2mm thick and a dielectric protection 30 KV. A second coating of TM198 was applied to achieve 4mm thickness and a dielectric coating and protection of 60 KV. This dielectric protection is an additional advantage for Site Safety.

A Polymelt 50 ATEX 2-22 machine was used for the application. The process took a total of 70 minutes to complete from cleaning through to end of application.
