Oxifree / Cygnus Ultrasonic Testing Case Study

Oxifree and Cygnus instruments conducted UT testing through applied TM198

Summary

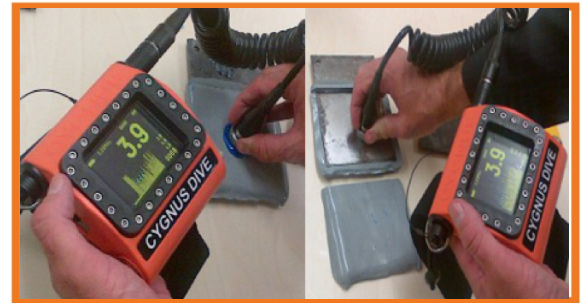
A variety of metal substrates were assessed using the Cygnus Dive UT Gauge. Test 1.

Test 1: 4mm blasted steel plate coated in Oxifree coating.

Measurement was taken through 6mm of Oxifree coating. The material was then removed from the exact spot of testing to demonstrate that the Oxifree coating had no effect on the thickness of the material reading.

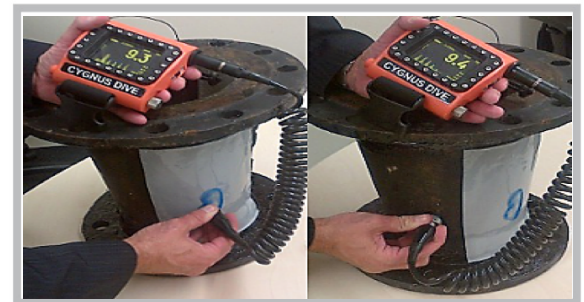
Test 2

Test 2: Gas transfer pipe partially coated in Oxifree coating.

This test involved measuring a section of the pipework coated in Oxifree material using Cygnus Dive UT gauge, then rotating the pipe to demonstrate that the only difference in reading is due to the manufacturing process.

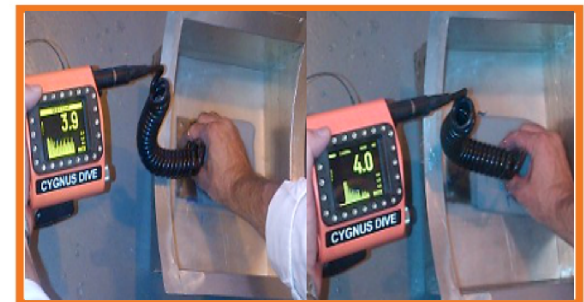
Test 3

Test 3: Testing of Oxifree coating while submerged.

A coated plate was submerged in water and tested for thickness as in the previous tests with the same level of results recorded.

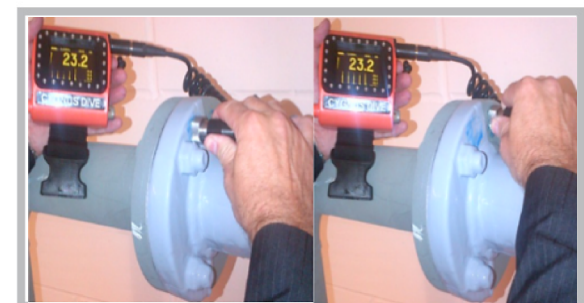
Test 4

Test 4: Testing Cygnus Dive on Oxifree Demonstration test piece.

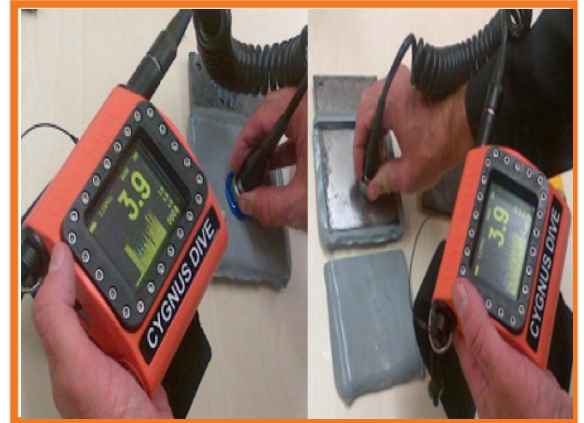
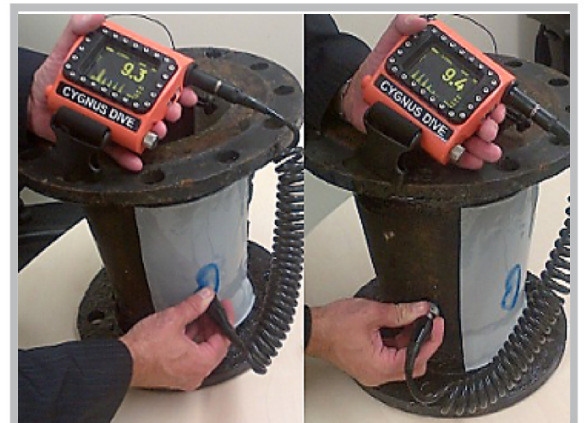
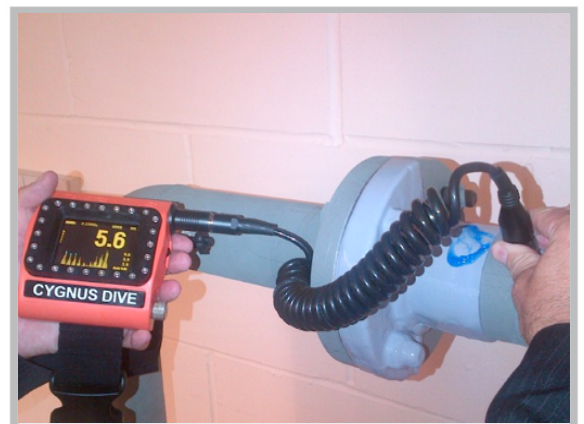
The various test conducted showed, without fail, that UT testing was suitable for TM198.
