Air Products Re-Visited

OXIFREE[®]
METAL PROTECTION

Routine maintenance shows successful protection TM198 provides.

Location	Rotterdam
Local Environment	Onshore
Date	28 th – 30 th Nov 2017
Condition	Wet, cold and windy
Total Coatings	1
Substrate Type	Gas Flange
Duration	3 Days

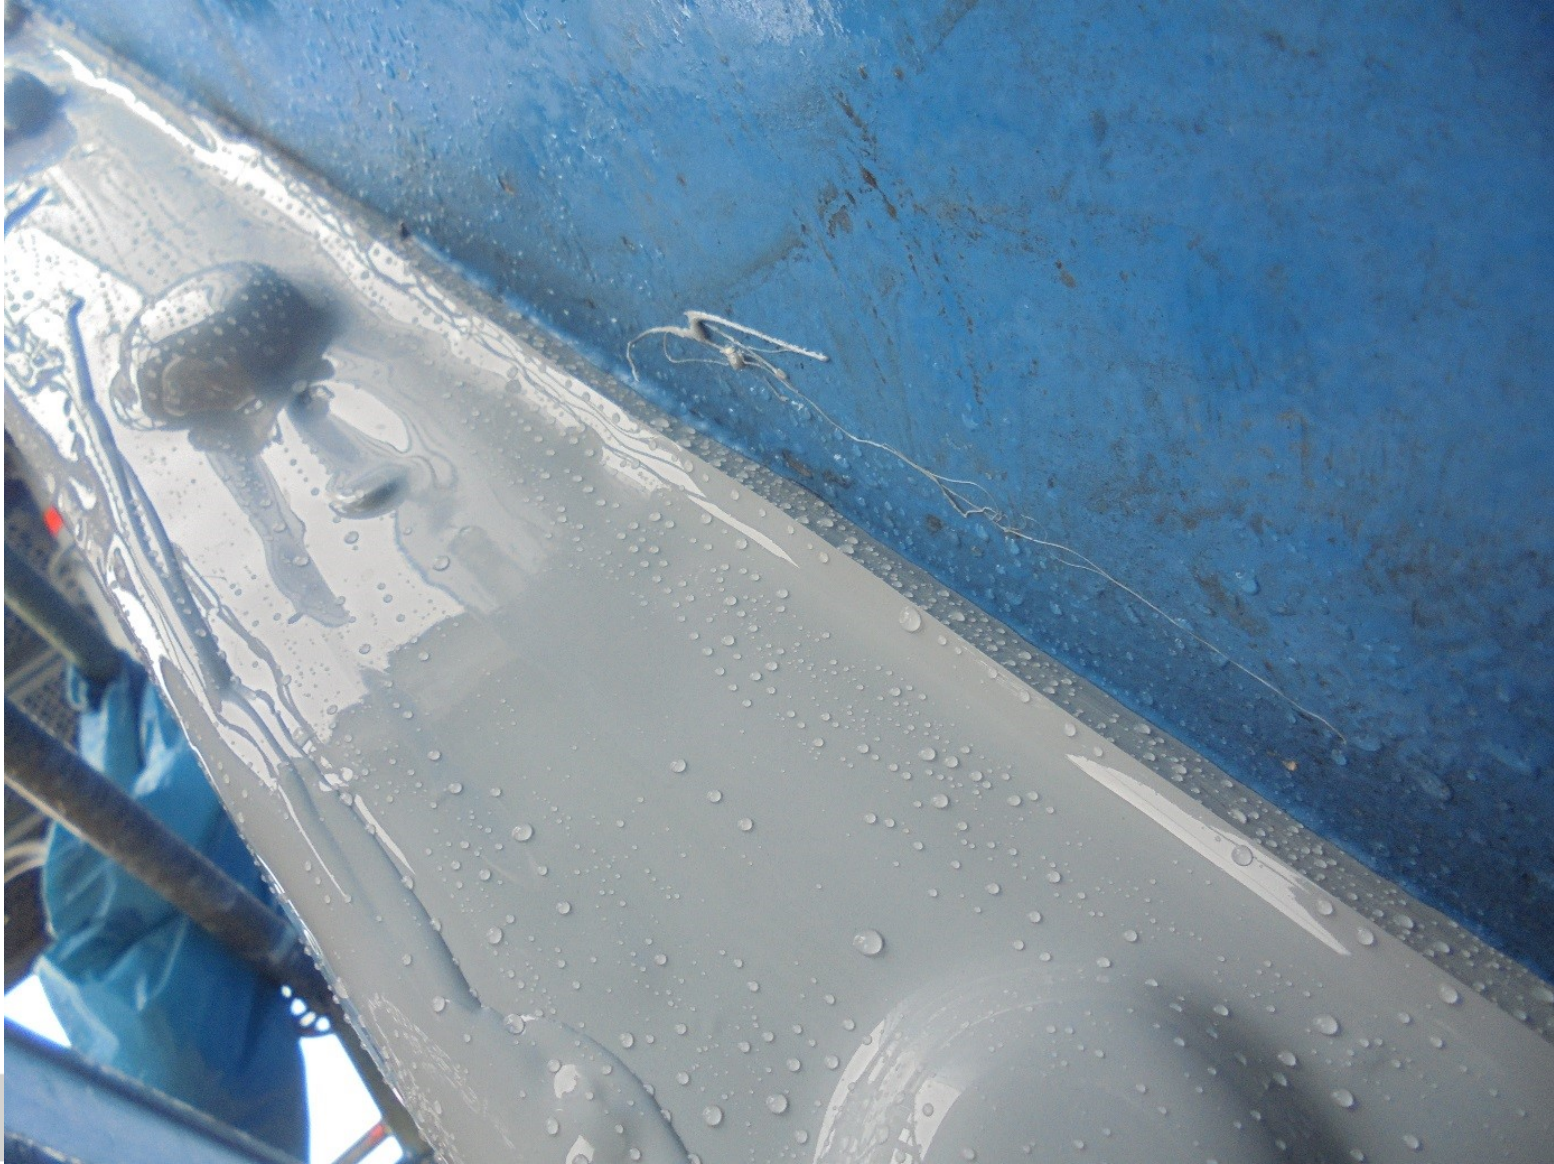
Air Products used to suffer with contamination to a vent/exhaust structure due to outside moisture entering and causing corrosion. The location of the facility, in close proximity to the coastline, puts it at risk from corrosion with the mixture of salt and moisture in the air.

Oxifree TM198 was initially used to protect this flange in 2012, but in 2017 the material had to be removed for routine maintenance. TM198 was demanded again to reapply.

The objective post-maintenance was to re coat the flange with new material.

Oxifree TM198 was applied over the whole gas flange. The material will cure instantly and prevent water ingress and at the same time protect the nuts and bolts from corrosion. Despite the wet and windy conditions the application was able to go ahead with success.

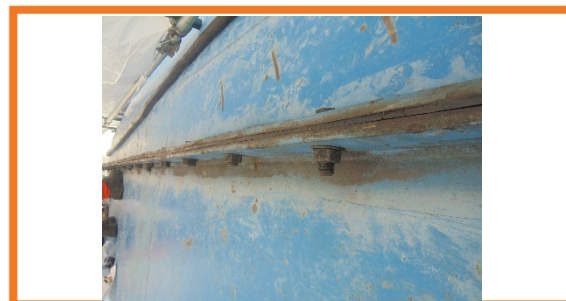
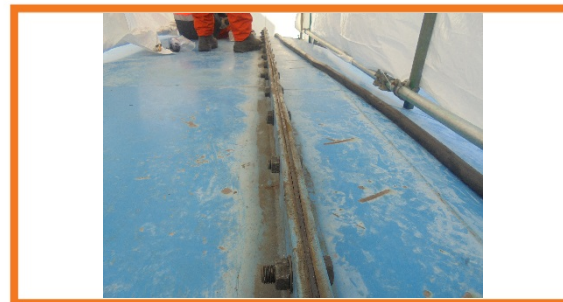
Before

As you can see by the photos, the original nuts/bolts were able to be re-used due to the protection provided by the initial TM198 application in 2012.

Surface preparation was minimal, a wire brush was used to remove any loose debris. Prior to application, compressed air was used to dry the flange.

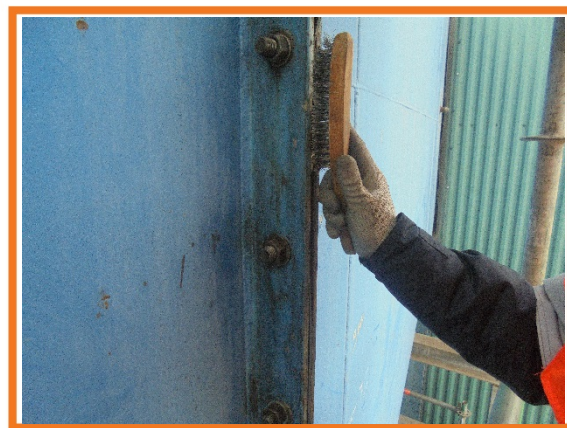
Surface Preparation / Application / Inspection

The nuts/bolts were coated first, then applications started at the top of the flange, then the sides and finally the bottom section was coated with TM198. An Elcometer 456 was used at regular intervals to maintain the correct material thickness (>4mm). Silicon was used on the leading edge of the material for added protection.
