Riser Turret Flange Protection – Offshore Oil Offloading Tower

Case Study

Corrosion Prevention On Riser Turret Flanges

Location	F3-FB-1-OLT, Netherlands
Local Environment	Offshore Oil Offloading Tower
Date	August 2018
Condition	Dry
Total Coatings	9
Substrate Type	Flanges With Bolts
Duration	2 Days

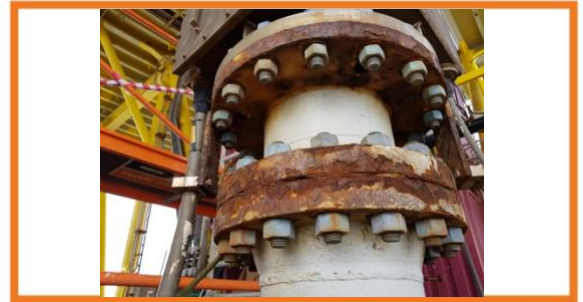
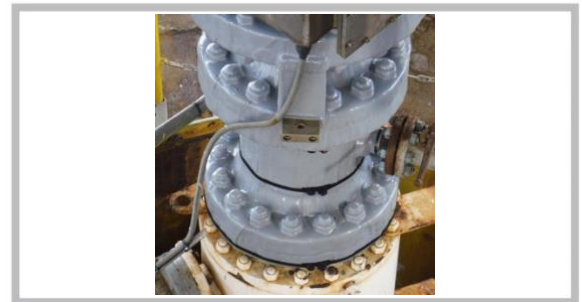
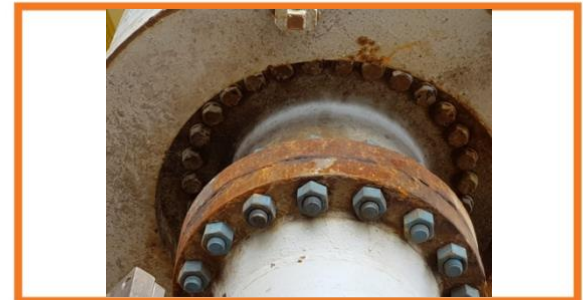
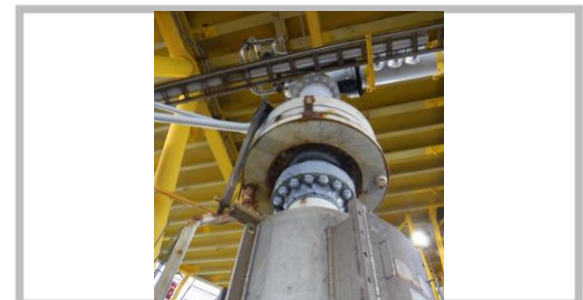
The photos show the state of corrosion the flanges were experiencing.

Oxifree were requested to carry out the coating of Oxifree TM 198 on 9 flanges to halt existing corrosion and protect the bolted connections and gaskets.

The surface preparation was minimal, a wire brush was used to remove the loose debris, no degreasing or blasting was required and no habitat needed to catch any coating or blasting materials.

A 4mm coat was applied to each flange assembly which equated to approximately 25kg of material and the combined man hours for the coating equated to 16 hours for all flanges.

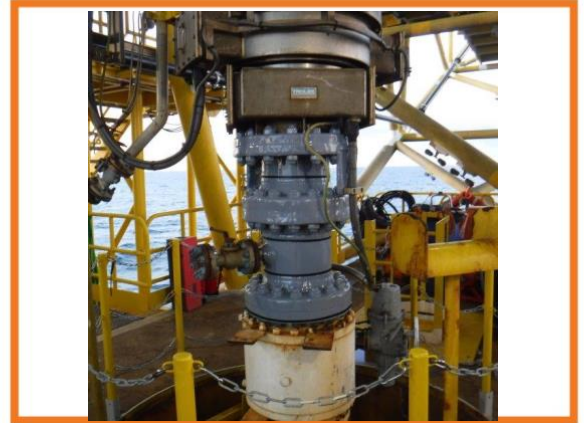
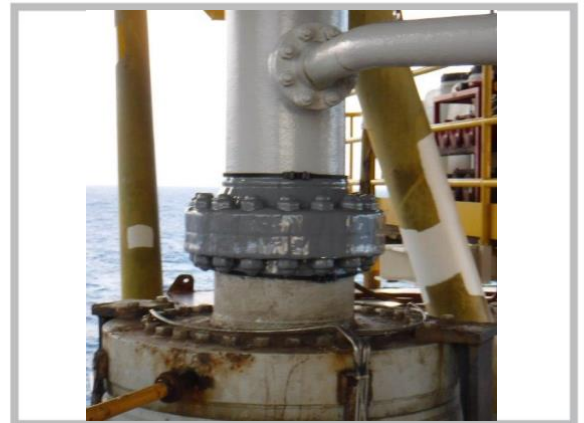
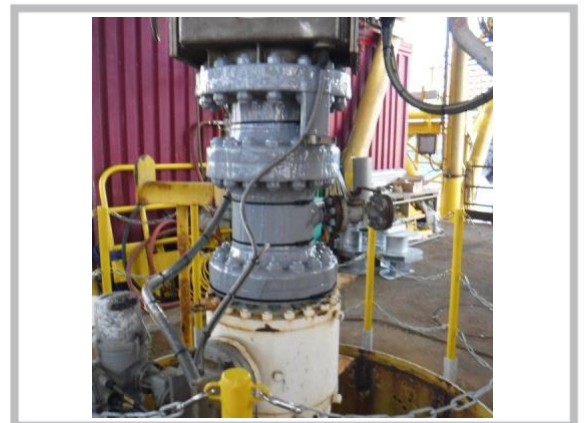
The coatings took place over 2 days and will provide protection immediately.

Nine flanges were coated in total with TM198 providing immediate protection against corrosion and contamination.
