Protecting foundation bolts on electricity pylon  
Case Study

## Corrosion Protection of Foundation Bolts on Electricity Pylons

Location	Bleiswijk, The Netherlands
Local Environment	Outdoors
Date	April 2017
Condition	Dry
Total Coatings	52
Substrate Type	Foundation Bolts
Duration	1 Day

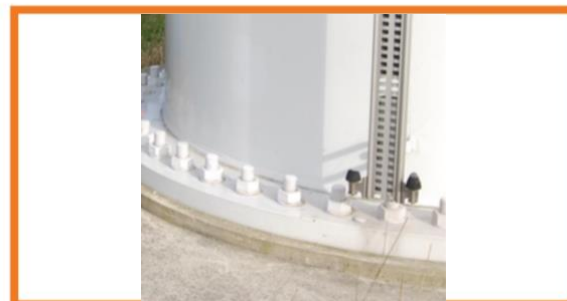
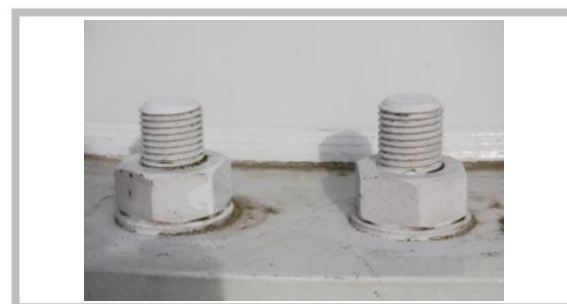
Oxifree were invited to carry out a trial coating of Oxifree TM198 on 52 bolts which currently suffer from corrosion due to the exposed location.

Before

Any loose rust was removed with a wire brush and in preparation, and to speed up the application process and minimise material use, a selection of moulds were placed in position over the Nut/Bolt structures.

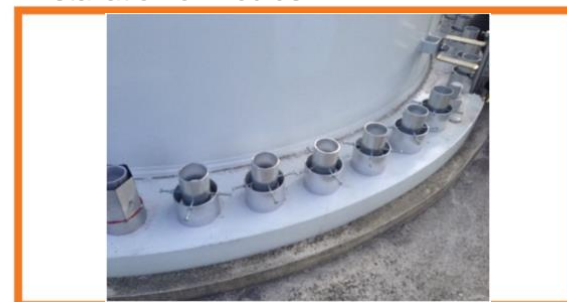
Installation of moulds

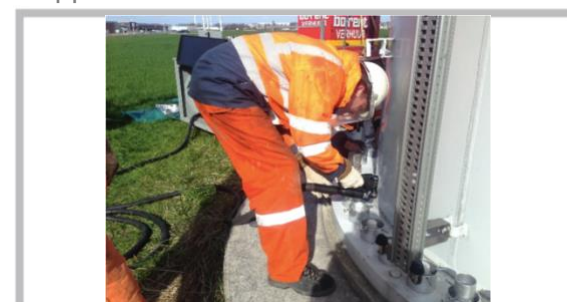
Application

The moulds were filled with TM198 using a Polymelt 50 applicator machine. The mould design can be further improved to minimise material usage and speed up the application process.

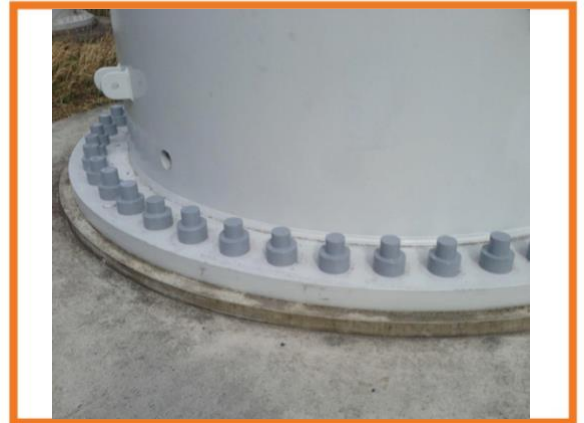
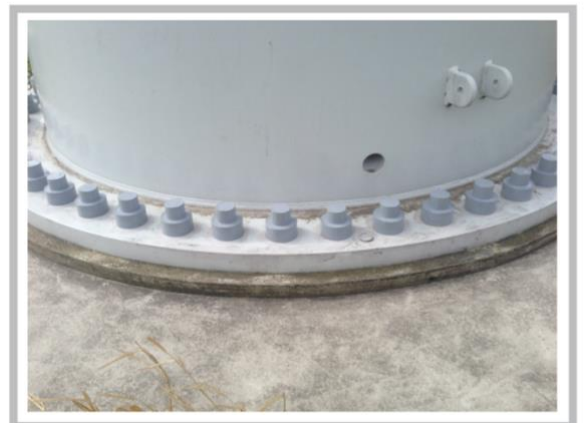
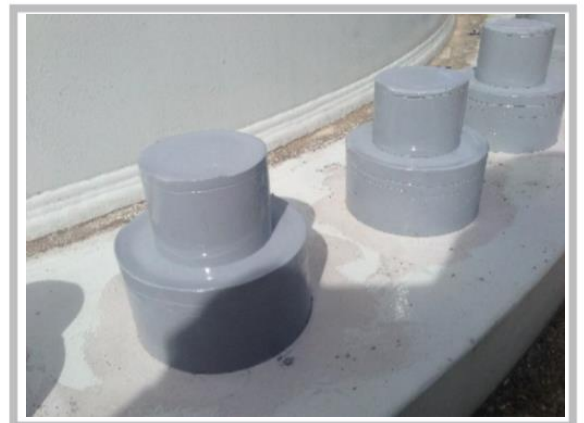
*Complete*

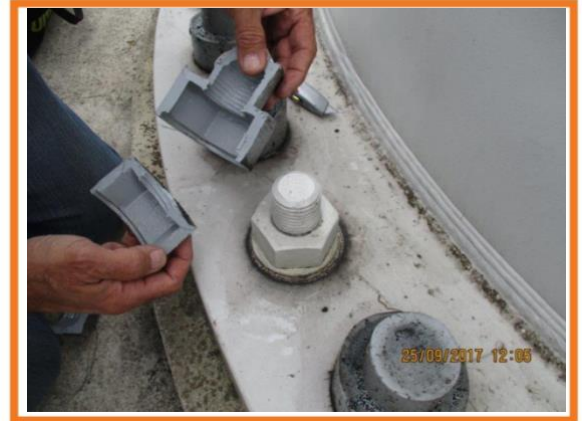
*Removal after 6 months*

Oxifree TM198 removed from 1 bolt 6 months after application shows the bolts are still in good condition with no evidence of corrosion present.

To review the protection TM198 was providing, 2 assessments were carried out at 6 and 22 months post application. The material was simply cut away with a knife and the material peeled off.

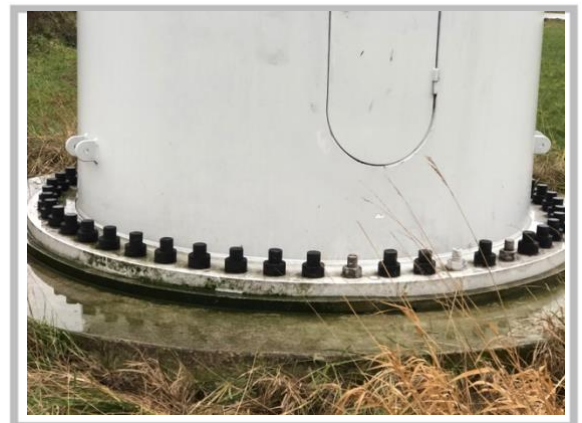
*Bolts 22 months after application*

You can see how the coating on the bolts have collected dust and debris having been exposed in this varied environment. In an unprotected situation this would have caused extensive corrosion, but this is not the case in the protected bolts.

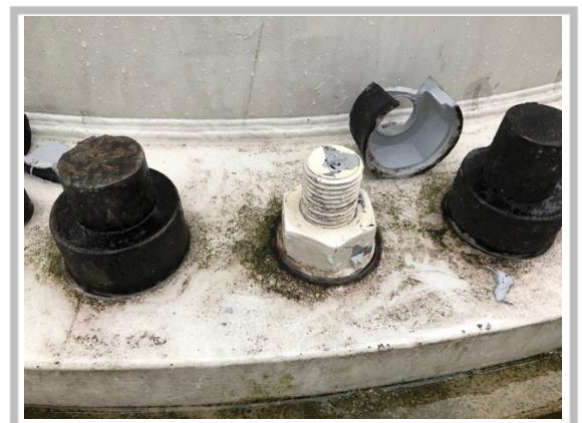
Oxifree TM198 was removed from 1 bolt 22 months after application to show the bolt was still in great condition and free of corrosion – ready for any maintenance that should be required.

*Removal after 22 months*

These exposed bolts were simply encapsulated once again in TM198 and will continue to be protected for many years to come. The trial was a success.
