## Protecting Wellheads Offshore Case Study

## Conducting an offshore pilot protecting wellheads for Total Exploration & Production

Location	K5A Platform
Local Environment	Offshore
Date	January 2016
Condition	Weather was dry with a little wind
Total Coatings	2
Substrate Type	Wellhead
Duration	7 Days (shuttling bet. platforms)

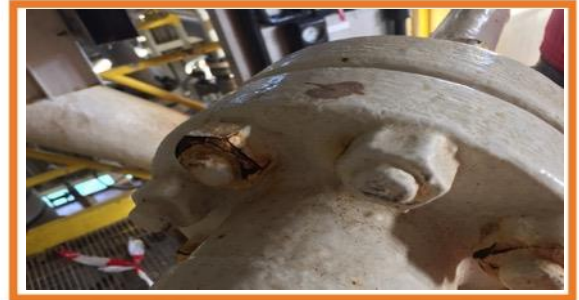
*Corroded bolts on the annulus flange prior to application of Oxifree TM198*

Oxifree TM198 requires minimal surface preparation - loose rust being removed with a wire brush. No sandblasting is necessary, which significantly saves costs. Weather conditions such as humidity and temperature are also not an issue saving the client further costs and eliminating the 'failure rate' of traditional coating systems such as paint. The wellhead manager at Total E&P we initiated the project with had experienced costly maintenance projects where changing weather conditions meant their equipment was left in a half-finished state and more venerable as a result. With Oxifree applications this is not an issue.

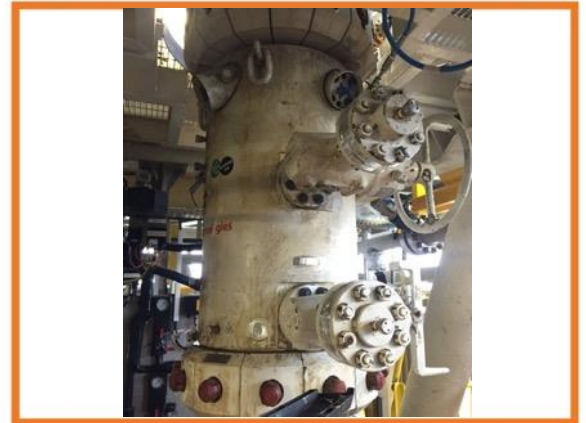
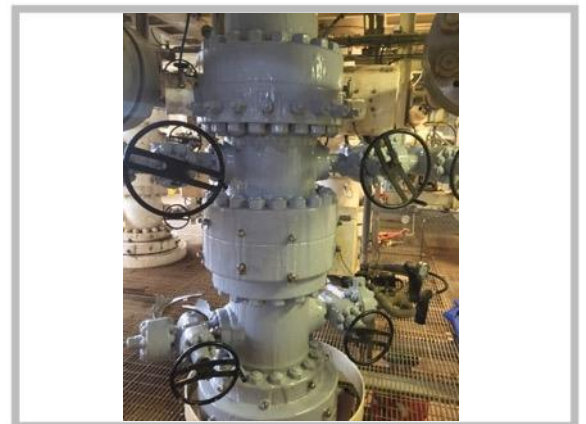
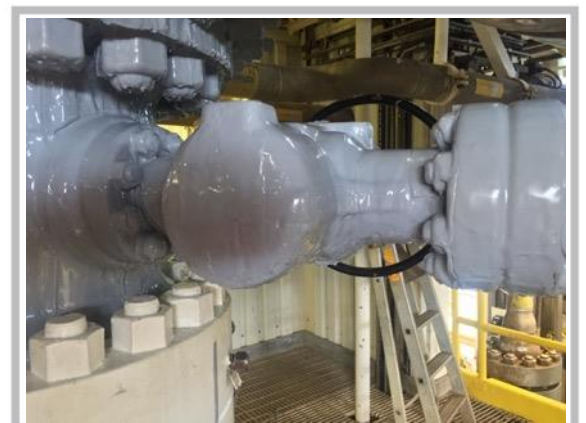
Oxifree applications were made to 2 wellheads, one complete and one in sections. The areas coated included flanges, valves, lock nuts and pipes – a variety of shapes and sizes. The initial project was to coat three wellheads, however shuttling between the work and accommodation platforms resulted in reduced man hours available, the applications were

downscaled accordingly by the Total E&P supervisor present onsite. The application will protect the well heads from corrosion in their harsh offshore environment. Due to the nature of TM198, the application could be made to live equipment and the product starts working immediately.

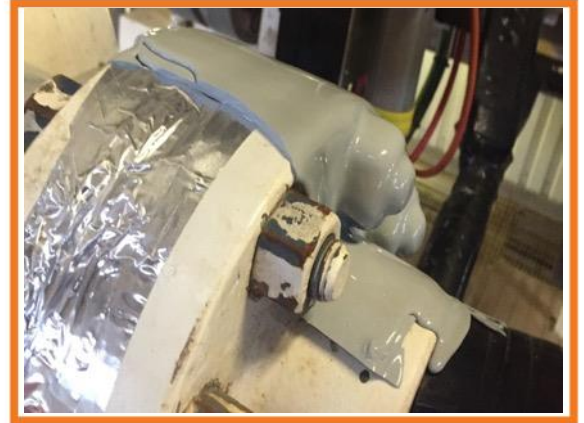
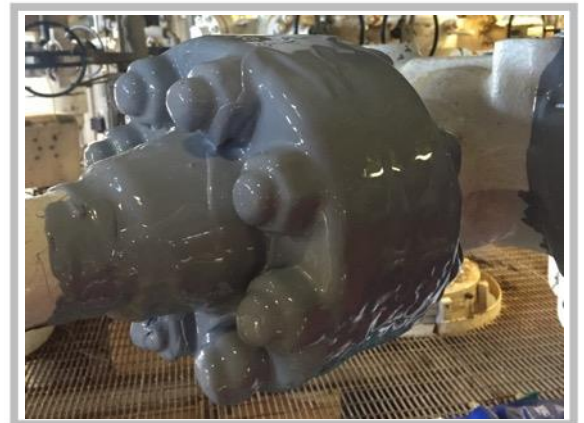
Whilst the wellheads were not in bad condition, corrosion was clearly visible. This project is an offshore pilot, however our representative recommended coating the other wellheads on the platform. The intention is for Total E&P to inspect the protected wellheads later in the year to see the level of protection that Oxifree TM198 has provided.

It would also be advisable for our representative to perform a full site visit on the platform to see the overall condition of the rest of the equipment. Protecting critical items such as flanges with Oxifree TM198 can save maintenance costs dramatically, which is especially relevant with low oil and gas prices and the aim on saving both capital and operational expenditure.
