Flange Protection – Offshore Platform

Case Study

Corrosion Prevention On Flanges

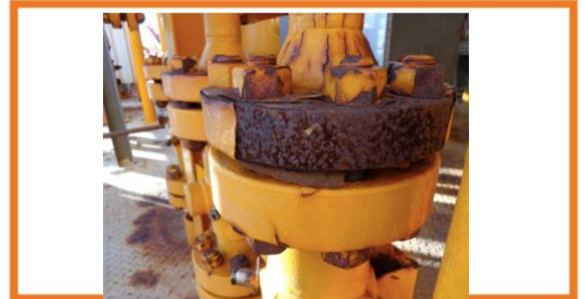
After

Before and after application photos, you can see the extent of corrosion.

Oxifree application technicians completed the project in 42 days. Oxifree TM198 was applied directly onto each of the flange assemblies as requested by the client. As OPS personnel were unable to paint due to the prevailing weather conditions, they assisted in this process using a needle gun to help remove the loose rust. Although this isn't necessary for Oxifree applications it did speed up the process.

A 4mm coat was applied to each flange assembly which equated to a total consumption of approximately 750kg of material.

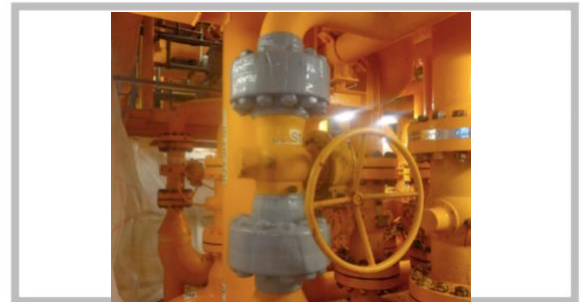
Before

There was severe corrosion on almost all of the flanges that were inspected on the platform. Traditional solutions of blasting/painting for these complicated shapes has clearly not been effective over the years, as well as being expensive, the paint locks the nut to the bolt and eventually corrosion sets in further lending the assemblies un-maintainable. Oxifree is the only viable cost-effective solution. This pilot project was deemed a success by ENGIE and as a result Oxifree was nominated for an innovation award within ENGIE.

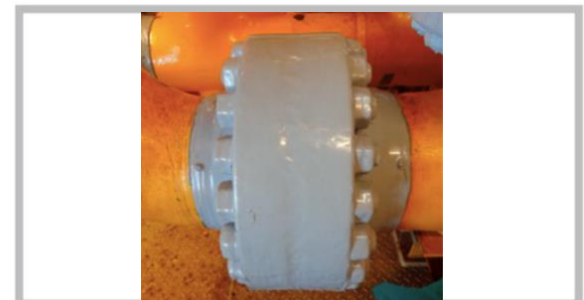
After

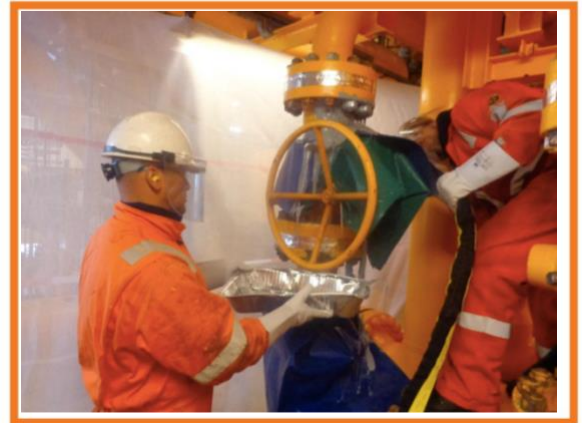
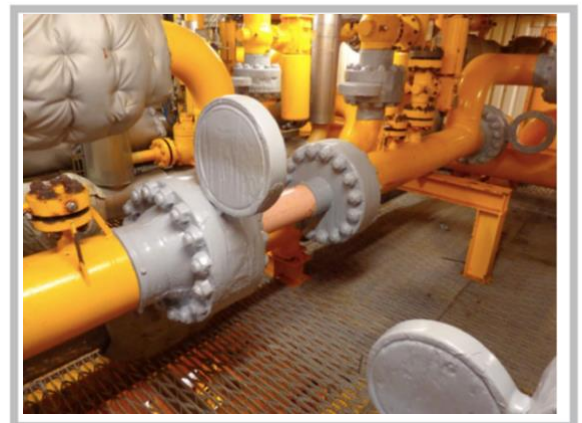
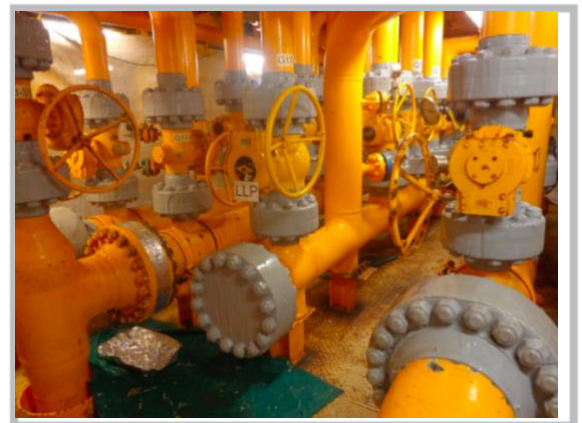
Oxifree application technicians completed the job.
