Flange & Conductor Protection – Storage Wellhead

Case Study

Corrosion Prevention On Flanges & Conductors

Location	Hengelo, Netherlands
Local Environment	Onshore Storage Wellheads
Date	October 2018
Condition	Dry
Total Coatings	4 Wellheads
Substrate Type	Flanges, Bolts & Conductors
Duration	6 Days

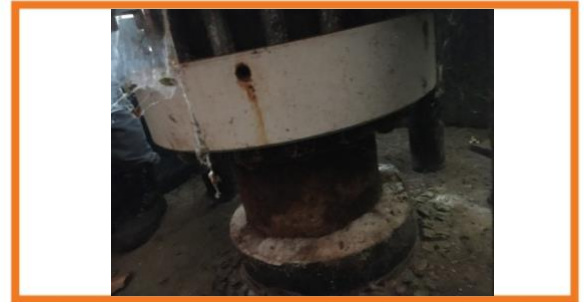
Lower flanges & conductors

There was severe corrosion on all of the conductors. Traditional solutions of blasting/painting for these areas was deemed as not a viable option by the client, since the paint solution locks the nut to the bolt and eventually corrosion sets in further lending the assemblies un-maintainable.

A 4mm coat was applied to each flange assembly and conductor.

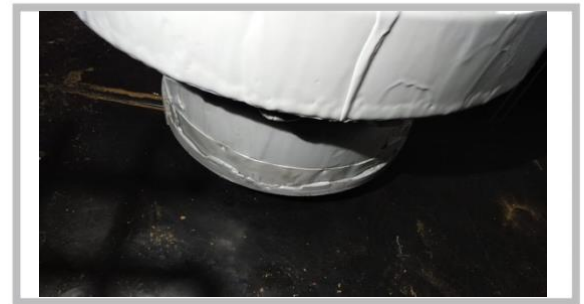
After

The coating, as approved by the operator, will ensure the flanges, bolts and conductors are protected for many years.
