Protection of Valves, Flanges and Gearboxes Case Study

Corrosion protection to prevent crevice corrosion in an aggressive coastal environment

Location	Oil tanking Tank Farm Malta
Local Environment	Marine Aggressive C5M
Date	2016 and 2017
Condition	Coastal Marine
Total Coatings	50 units and ongoing
Substrate Type	Steel Valves & Flanges
Duration	N/A

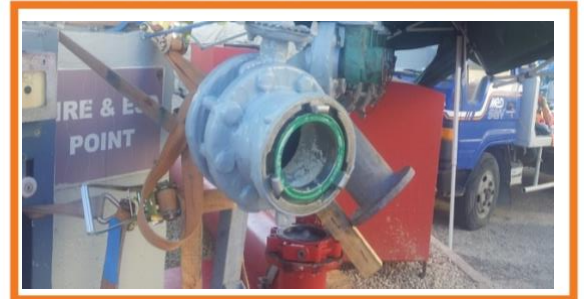
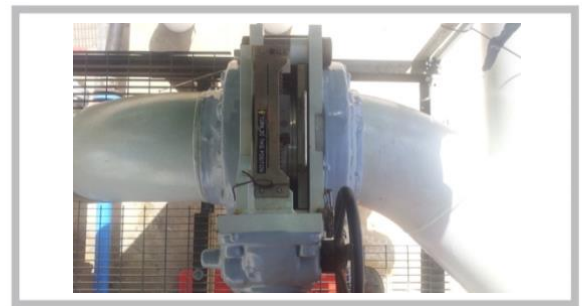
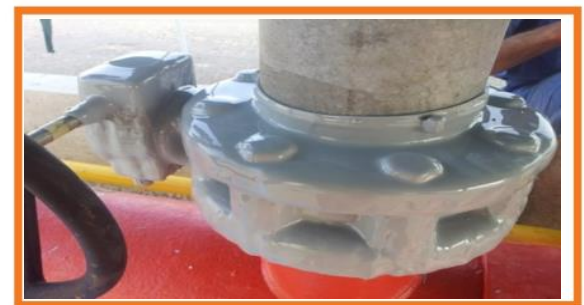
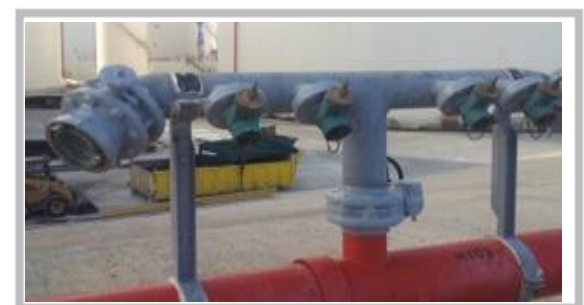
Photos of Completed Work following application of TM 198

The Oxifree team applied TM 198 following surface preparation procedures described. The Polymelt 50 Al was used in accordance with the HSE requirements for hazardous environments.

Aluminium tape was used on the large 18 and 14inch flanges in order to reduce material wastage between the flange faces. Any waste material during application can be reused.

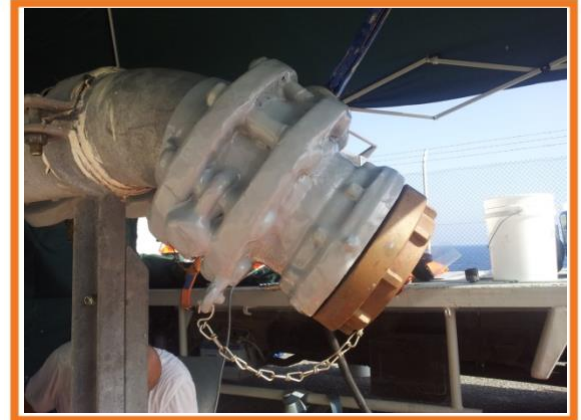
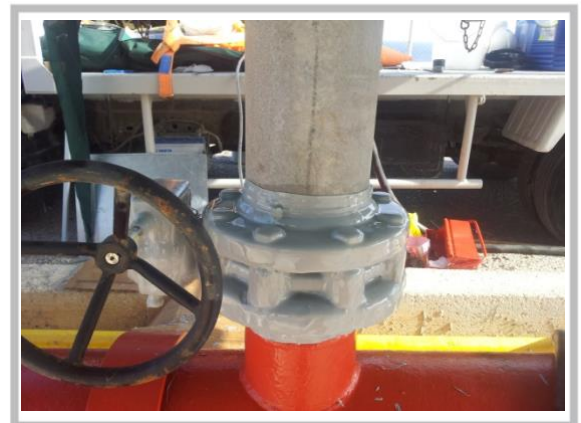
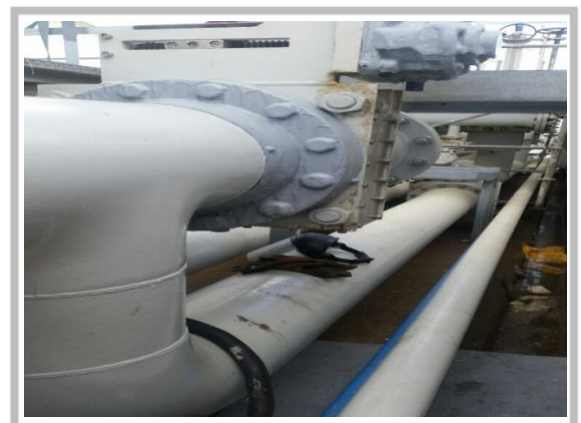
Photos of Completed Work following application of TM 198

As per standard application practice cable ties are used at the end of each part after application of first coat. This cable tie is sealed by the second coat of TM198 and ensures proper sealing at each end against moisture ingress.

Although TM198 was applied on moving parts, these can still be operated without any adverse effect on the Oxifree coating.
