Protecting critical parts in storage

Case Study

OXIFREE[®]
METAL PROTECTION

Protecting critical parts in storage so that they can be put into production without delay

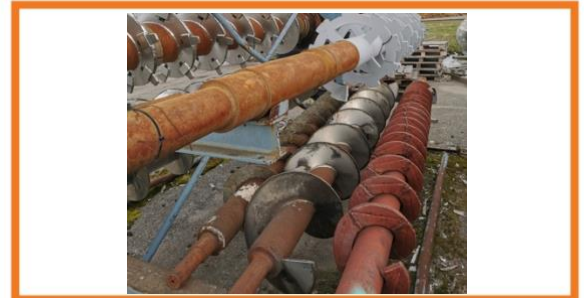
The parts were beginning to corrode prior to application of TM198
