Valve Corrosion Protection

Case Study

Location	Harthill Reservoir
Local Environment	Reservoir Tunnel
Date	March 2016
Condition	Damp
Total Coatings	2
Substrate Type	Gate Valves
Duration	1 Day

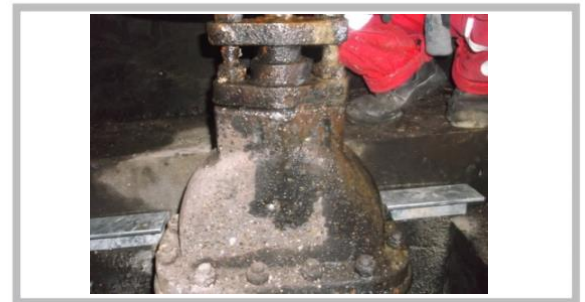
CPC Civils were carrying out the replacement of the drain pipes at Harthill Reservoir. The original valves that protruded from the reservoir wall showed signs of heavy corrosion and deterioration and needed to be operational should the flow require arresting.

Gate Valve Before Application

The 2 valves were cleaned of loose debris using a wire brush and hand brush, the area was covered with a tarpaulin to keep the work area dry and prevent the material coming into contact with the silt bed. A coating of a 4-6mm of Oxifree TM198 was applied in a time frame of 6 hours. Upon departure the area was locked and sealed to prevent unauthorised access.

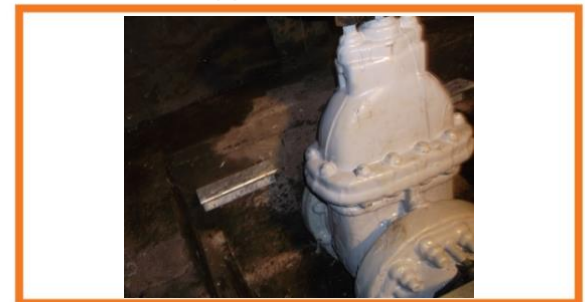
After TM198 application

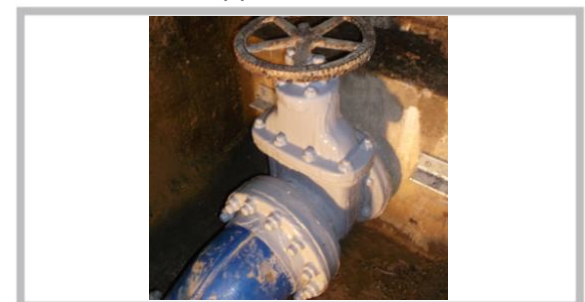
After TM198 application
