Life Asset Extension for Corroded Pipe Supports

Case Study

Addressing Corrosion Under Pipe Supports (CUPS)

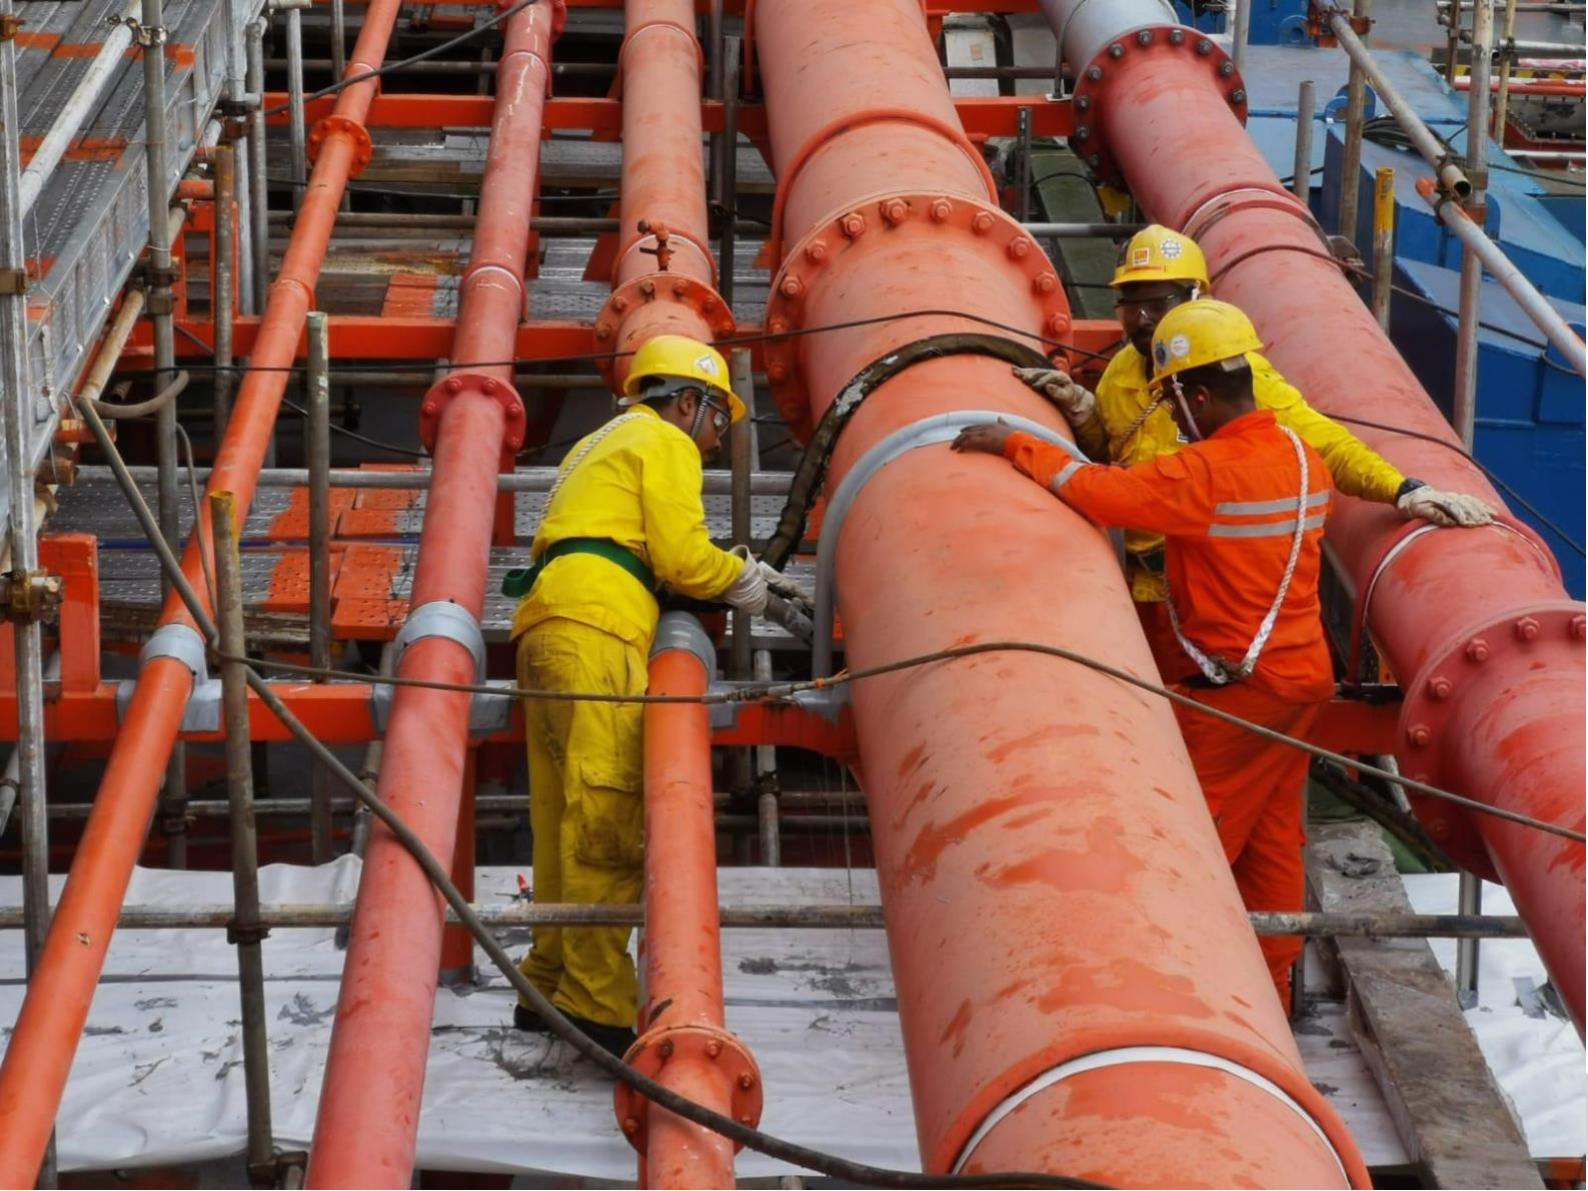
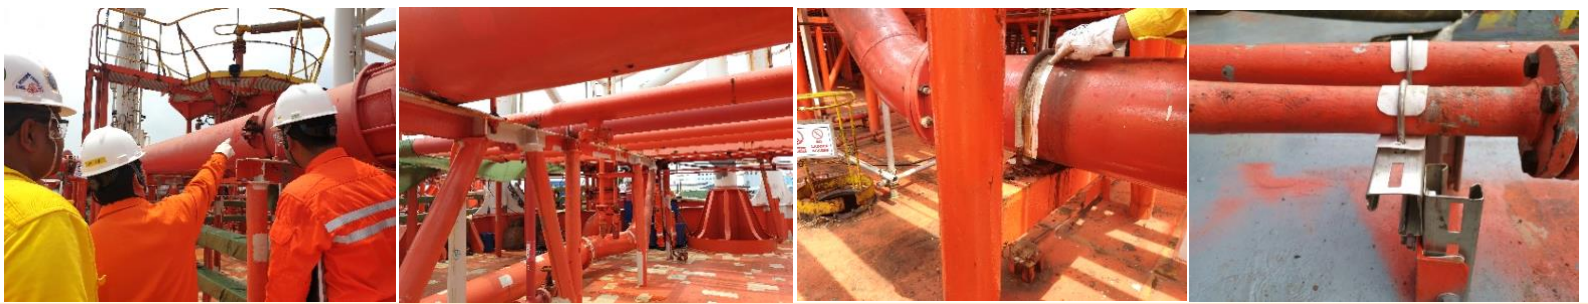
Pictures of the substrates with Oxifree TM198 after job completion

Mun Siong carried out Oxifree TM198 application on a FPSO which had pipe support/flange components that were heavily corroded, due to salt and water exposure in offshore environment. After encapsulation with TM198 the pipe supports were completely protected from any further corrosion damage caused by the harsh offshore environment.

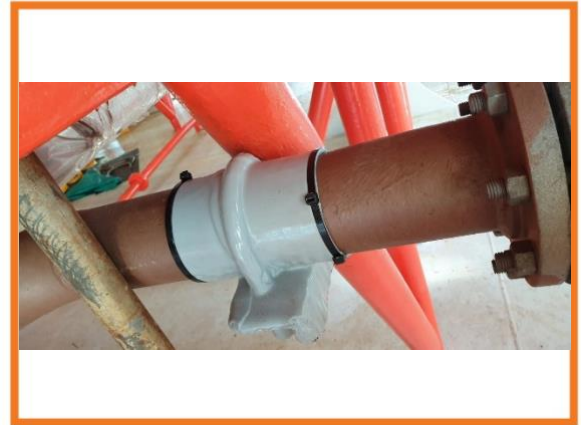
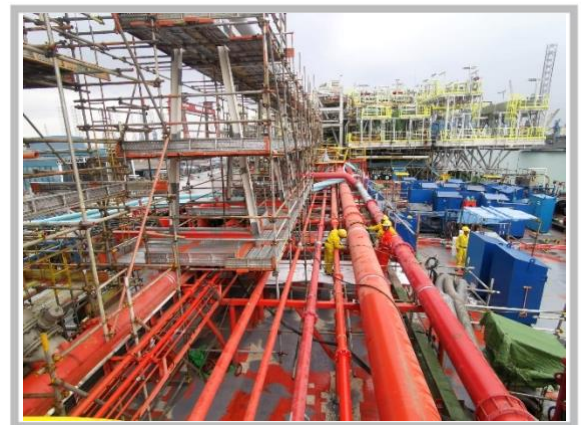
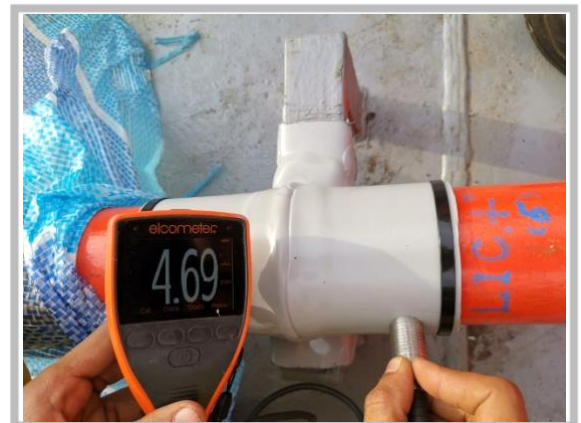
Pictures of the substrates with Oxifree TM198 after job completion

The 190 substrates were successfully coated, offering immediate and long lasting protection on the salt spray exposed substrates. Oxifree Anti -Corrosion Thermoplastic (ACT) coating is deemed to be the best solution to address CUPS corrosion effectively.
