Case Study

Total pipeline protection with Oxifree TM198 and Oxitape

Romson Oilfield Services carried out Oxifree TM198 and Oxitape application on surface to ground pipeline interface in Eket, Nigeria.

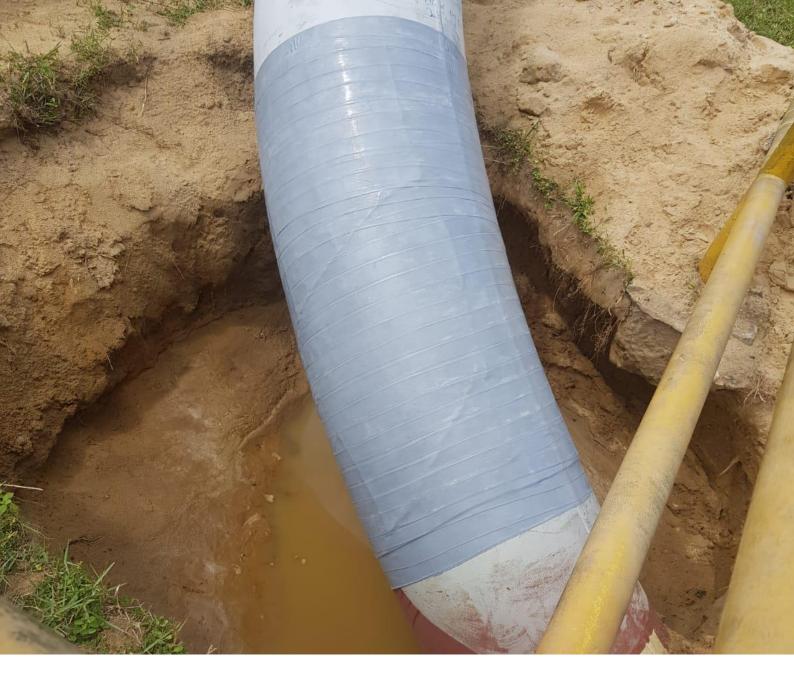
Protection of pipeline against abrasion with Oxitape

The area was heavily corroded due to the heavy rains and ground abrasion. After application of TM198, Oxitape was applied to provide a hard protective shell which will withstand the harsh abrasion suffered by backfill and high water tables experienced in this region.
