Ed Hall, Oxifree, UK, discusses how thermoplastic coatings can save operators time and money when protecting pipelines from damage caused by corrosion.

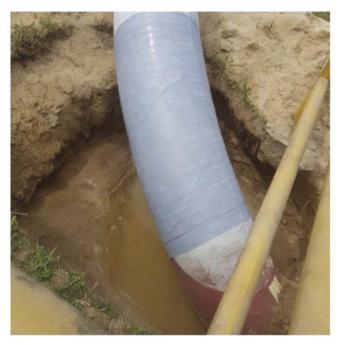
Figure 1. Complete pipeline protection provided by TM198 and Oxitape.

In Nigeria total pipeline protection was required in a surface to ground interface for a major oil operator. The area requiring protection is subject to harsh abrasion by backfill and high water tables: notorious for accelerated corrosion issues. Previous application of a protective tape had not stood up to the elements which are obviously varied and extreme. In this instance the use of a thermoplastic coating followed by a protective tape over the top was used. The protective tape provided a hard shell against impact and abrasion, allowing the thermoplastic to provide corrosion protection underneath, exuding an inhibitor oil which would penetrate existing corrosion and stop new corrosion.

Application of TM198 is not affected by high humidity or damp surfaces. With this case in Nigeria, the client was impressed by the application process being so quick and that progress was made in between periods of torrential rain. Both Oxifree TM198 & Oxitape can be exposed to moisture after application, providing immediate protection. In addition, they can both be applied to live equipment so there was no operational shutdown required.

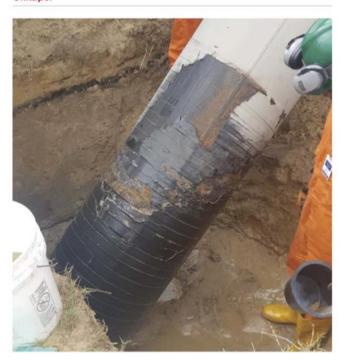
Figure 2. Previous tape protection had not stood up to the abrasive ground to surface environment.

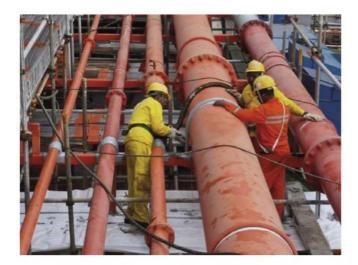
Figure 3. Minimal equipment solutions will be welcomed in a post covid world
