Wellhead Corrosion Prevention Services

Case Study

Life Asset Extension for Corroded Wellhead

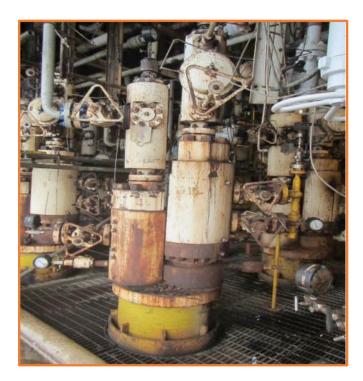
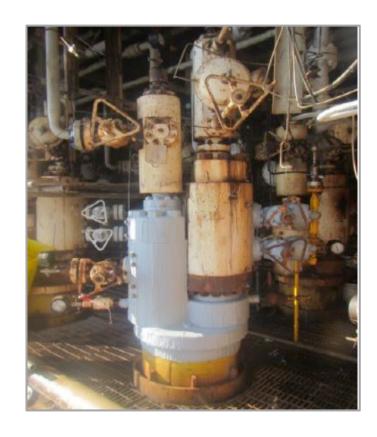
Follow up inspection After 15 months

The inspection outcome showed TM198 had provided 100% corrosion protection to the wellhead.

The coating is intact and there was no damage to the coating which is able to withstand impact from any scaffolding activities.

Small circular cuts to the coating were made in line with inspection guidlelines (red dots in the picture on the right) and zero corrosion was observed. There were inhibitor oils on the surface of the substrate where the coating removed, which was exuded by the material upon application. These oils actively protect the surface of the substrate.
