Protection of a drain valve showcases TM198 success

Case Study

Location	CPG Morelos, Coatzacoalcos
Local Environment	Onshore
Date	November 2014
Condition	Dry, windy
Total Coatings	1
Substrate Type	Valve
Duration	1 day

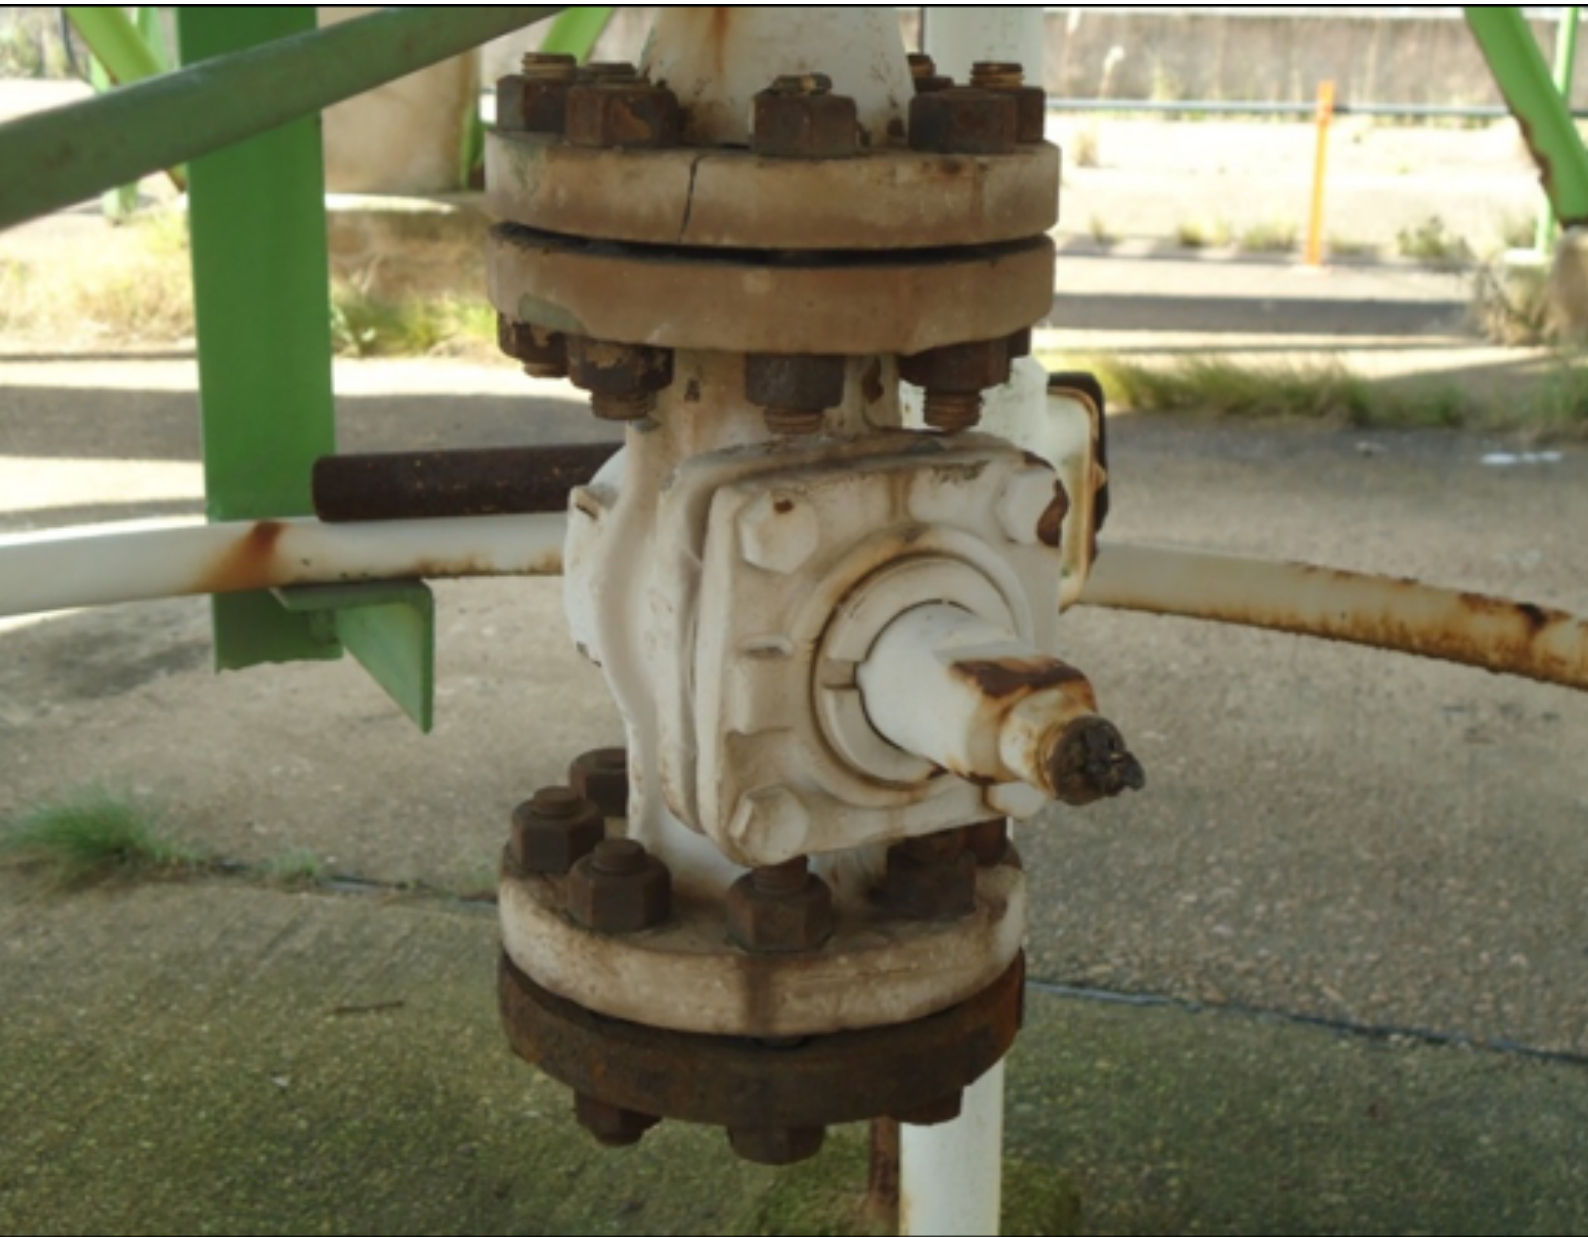
Successful protection of a drain valve heavily corroded with rust and paint cracking.

Drain Valve 2 "300 # in TE-5507 CPG Morelos was found to be heavily corroded with rust and paint cracking. It was decided the area should be cleaned of all contaminants including grease and prepared for the application of Oxifree TM198. TM198 was the best solution as no shutdown was required, the surface preparation required was minimal and did not require additional equipment.

The drain valve was cleaned of contaminants and grease.

Oxifree TM198 was applied to the recommended thickness of 4mm which has a dielectric coating and protection of 60 KV. This dielectric protection is an additional advantage for Site Safety.

A Polymelt 50 AI machine was used for the application. The process took a total of 50 minutes to complete from cleaning through to end of application. Despite the windy conditions the application was a success.
