Protecting flanges onshore

Case Study

Protecting an onshore processing plant from further corrosion

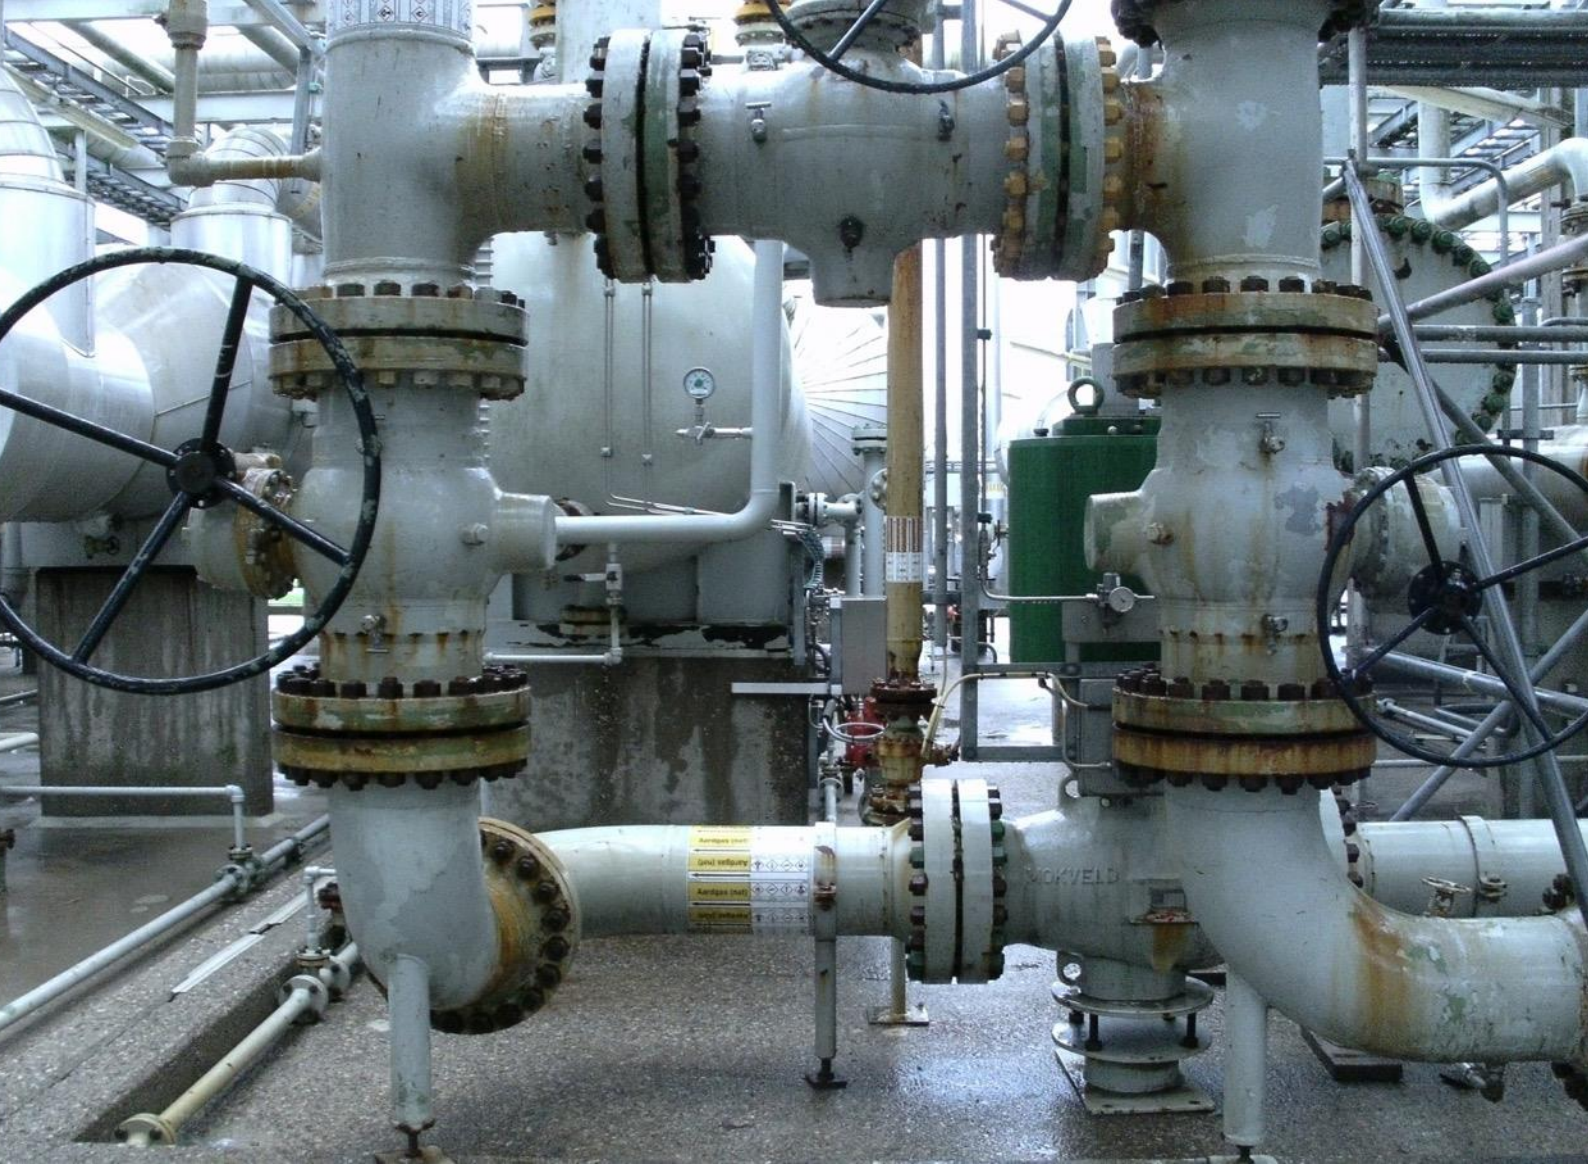
The extent of corrosion can clearly be seen before application

TM198 provided the perfect solution being applied with minimal preparation to live pipework, halting further corrosion
