**Dŵr Cymru**  
**Welsh Water**

**END OF JOB REPORT FOR OXIFREE  
COATING ASSETS  
BRITHDIR MAWR RESERVOIR  
FEBRUARY 2019**

Orbis asset Integrity Ltd  
12 Wilkinson Business Park  
Clywedog Road South  
Wrexham Industrial estate  
Wrexham  
LL13 9AE

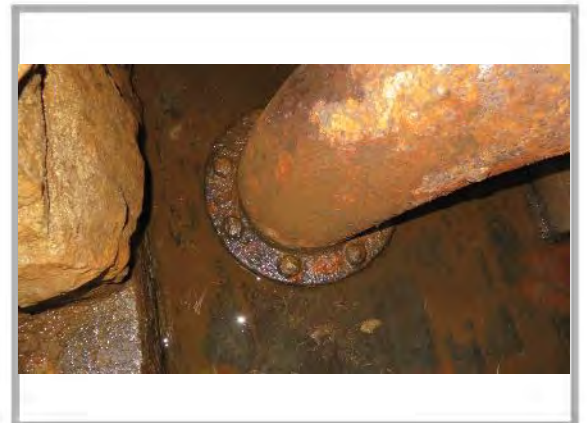
The surface of the valves and flanges were dried off as much as possible and were subjected to wire brushing to remove as much loose material as possible to minimise contamination of the product during 'run off' for re-use. Compressed air was also used to blow off loose material and also dry the surface. The original plan was to coat the flange going into the ground but was deemed too wet as a lot of surface water was present.

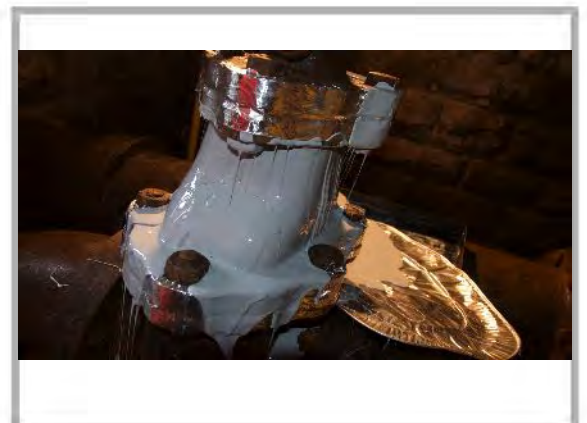
Both valves to be coated were closed because when opened and cold water flowing through condensation formed on the outside. The valves were wire brushed and compressed air used to blow the surface rust away. This is one of the major properties of Oxifree where only loose particles of rust have to be removed and not be subjected to blasting down to bare metal. The natural leeching of oil from the product contains an inhibitor which prevents any further corrosion along with the fact that oxygen is removed when the encapsulation takes place. It can be seen in the photo at the bottom right, the upper concrete plinth which was coated along with the valve and flanges.

Aluminium tape was used to cover the flange gaps to prevent Oxifree from entering. Reasoning that makes it easier to remove the coating and also saves the client money in reduced product usage.
