Coating on Operational Riser Turret

Life asset extension for riser turret and flanges on a FPSO deck

Case Study

Application of TM198 coating on live riser turret and selected flanges on the deck of the FPSO

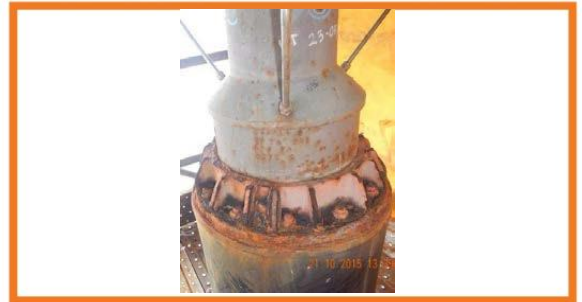
The extent of corrosion can clearly be seen before application

The Oxifree material (TM198) is melted in Polymelt 12 machine. The coating is then applied in 2 layers onto the surface of the selected flanges with the minimum thickness of 4mm achieved.
