TENNET – protecting onshore monopile nuts and bolts

Case Study

Oxifree TM198 Nut/Bolt encapsulations.

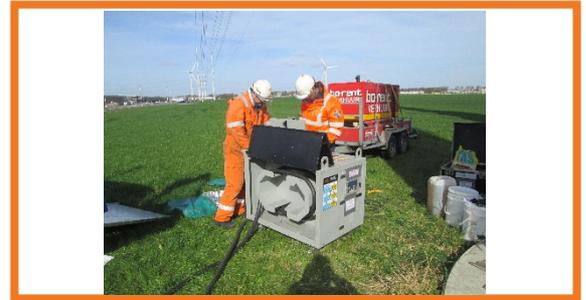
Moulds were used to help with the application of material, following a simple preparation.

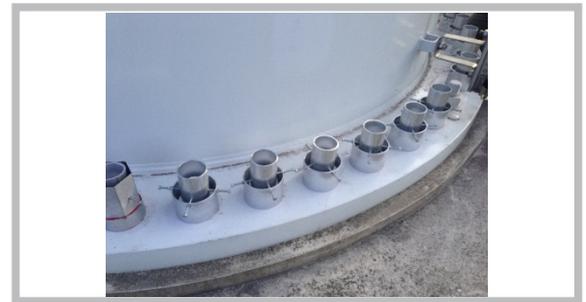
Moulds

In order to speed up the application process and minimise material use, a selection of moulds were placed in position over the Nut/Bolt structures.

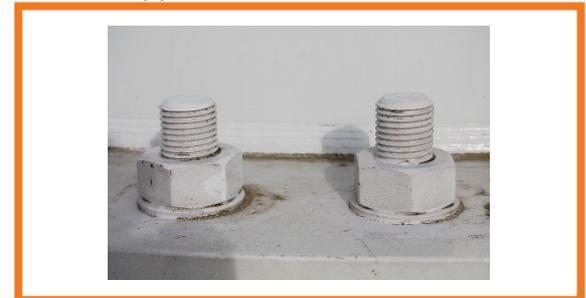
Before Application

On the 15th of March 2017, Isolatie Combinatie Beverwijk (ICB) and our representative were asked to perform a site visit to inspect the mounting nuts/bolts on an electricity monopile in Bleiswijk. The nuts/bolts are especially vulnerable to corrosion, with their only protection until now, being paint. The mounting area is exposed to the environment, putting it at risk of corrosion from all environmental factors.

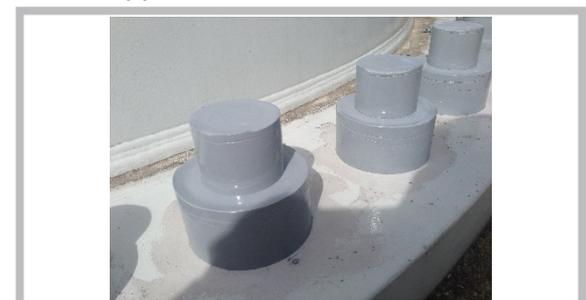
After Application

The Oxifree Supervisor filled the moulds with melted Oxifree TM198 material. All 52 bolts were successfully coated in 1 day and there was no interruption to service as TM198 can be applied to live equipment without a shutdown.

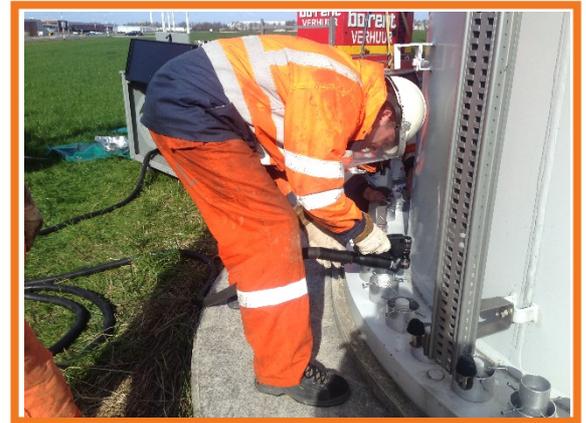
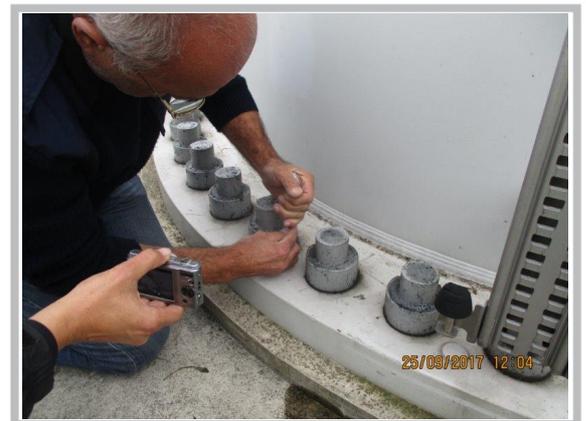
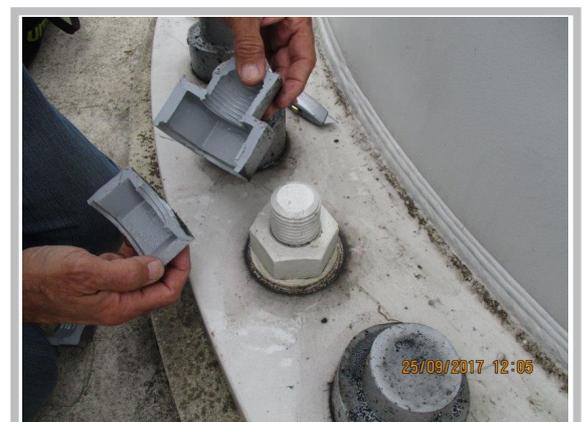
The Oxifree TM198 material was removed on 3 bolts and you can clearly see there was no visible corrosion underneath the material.

The Nuts/Bolts were still in the same condition as when they were coated showing the effectiveness of TM198.
